## 1.0 Purpose of and Need for Action

The North Lake Shore Drive (NLSD) study corridor extends approximately seven miles from Grand Avenue to Hollywood Avenue. See Exhibits 1 and 2 in Appendix A. The corridor is comprised of the eight-lane “Outer Drive” boulevard and the parallel two to four-lane “Inner Drive” local access roadway that is variously named North Lake Shore Drive, Sheridan Road and Marine Drive. The Outer Drive is designated as US 41 from the south study limit to Foster Avenue, where the US route designation continues west on Foster. The Outer Drive between Foster Avenue and the northern terminus at Hollywood Avenue is an unmarked State route. The Outer Drive is on the National Highway System which consists of roadways that are important to the nation’s economy, defense and mobility.

North Lake Shore Drive Phase I Study

North Lake Shore Drive Phase I Study  
**Study Area Map**  
 Grand Avenue to Hollywood Avenue  
 January 2, 2014

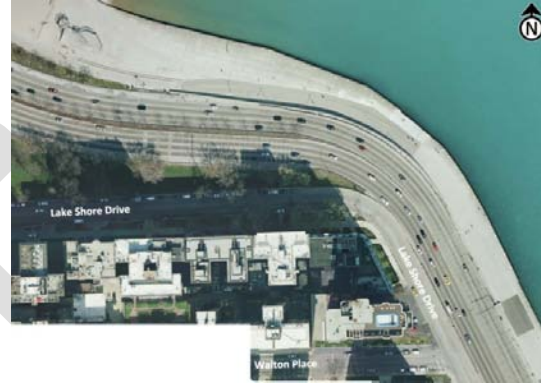
**Oak Street Curve** - Fifty-six percent of the crashes on the Oak Street curve were off-road fixed object collisions with the barrier walls that line the curve. Of all of the crashes on the curve, 76% occurred during wet or icy conditions. The maximum safe operating speed on the Oak Street curve under ideal conditions is 30 mph (25 mph posted advisory speed), which is substantially lower than the prevailing speeds of traffic. Despite the geometric limitations of the Oak Street curve and the 40 mph posted speed limit, hourly 85<sup>th</sup> percentile speeds immediately north and south of the curve have been measured to be as high as 68 mph. Compounding the challenge of negotiating the curve is the fact that lane widths on NLSD are 10 feet wide on the curve.

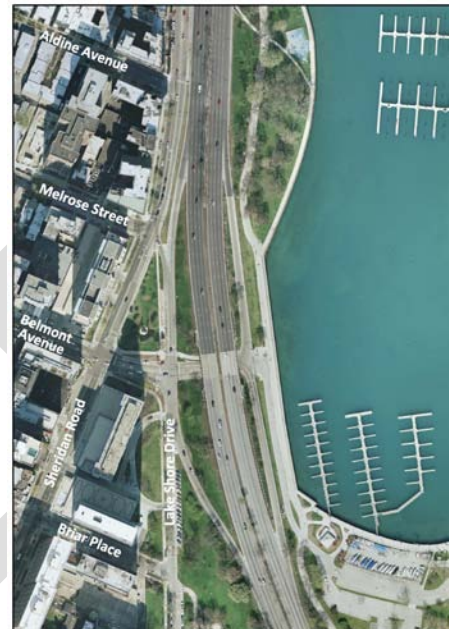
**Belmont Avenue Junction** - The Belmont Avenue junction provides the only access to and from NLS D for a distance of two miles, which concentrates heavy entering and exiting traffic volumes at this location. The junction forms the nexus of NLS D, Belmont Avenue, Inner Lake Shore Drive, Sheridan Road and the south harbor driveway in a complex of four signalized intersections that are spaced only about 200 feet apart. Nearly half of the 819 crashes at Belmont Avenue occurred at the four signalized junction intersections, which is indicative of the high levels of traffic congestion which exist at this location for many hours of each day.

A total of 210 rear end and sideswipe crashes occurred at the mainline ramp terminals for the ramps to and from the south. The crashes indicate that exiting vehicles may have difficulty decelerating before encountering vehicles queued at the ramp signal and entering vehicles may be unable to safely merge into the southbound mainline traffic flow.

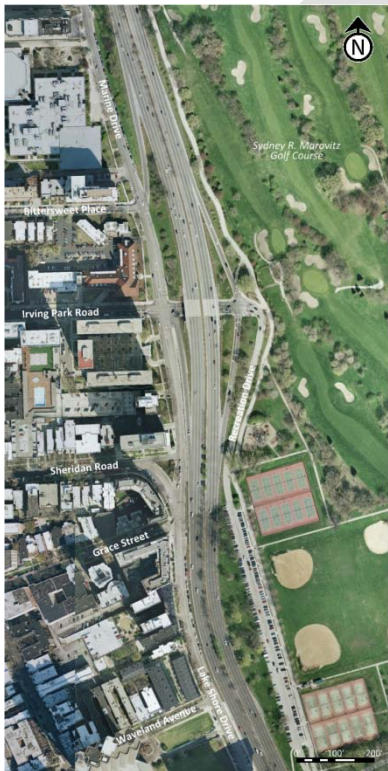
**Irving Park Road (IL 19) Junction** - Of the 104 fixed object crashes that occurred at the Irving Park Road junction, 81 of them occurred on mainline NLS D south of the Irving Park Road overpass. North Lake Shore Drive in this area has reverse horizontal curves that have smaller radii than adjoining roadway sections in concert with vertical curves for the Irving Park Road overpass. The concentration of fixed object crashes at this location, many of which were of high severity, would indicate a potential problem with the combination of horizontal and vertical roadway alignment south of the bridge and vehicle speeds.

Of the 17 fatal crashes that occurred in the entire NLS D study area, five occurred within this roadway section. Four of the five fatal crashes occurred between the hours of 11 P.M. and 5 A.M. and three occurred in the southbound direction. Although the posted speed limit is 40 mph, the free-flow hourly 85<sup>th</sup> percentile vehicle speeds measured along this section of NLS D throughout the day averaged between 60 and 65 mph and increased to as high as 70 mph in the early morning hours.

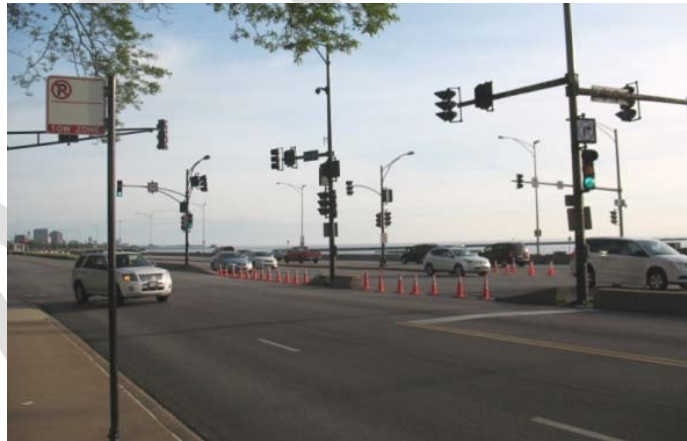
**Chicago Avenue Intersection** - Chicago Avenue, which is the only signalized intersection on NLSD, causes substantial mainline congestion, especially northbound during the P.M. peak period. Northbound queues can extend nearly to Monroe Street, which is about one mile to the south. Southbound queues in the afternoon can extend as far as the Michigan Avenue exit ramp, nearly ¾-mile to the north. Eastbound Chicago Avenue experiences long vehicle queues during the P.M. peak period as well. The intersection LOS in the P.M. peak hour is Level “F” (average delay = 129 seconds/vehicle).

In the A.M. peak period southbound queuing is not an issue because turning movements to and from Chicago Avenue from the Outer Drive are prevented by traffic cones during the morning peak period (i.e. Chicago Avenue only intersects with the Inner Drive during these times). The A.M. road closure, however, creates accessibility issues for educational institutions and hospitals located on Chicago Avenue west of NLSD.

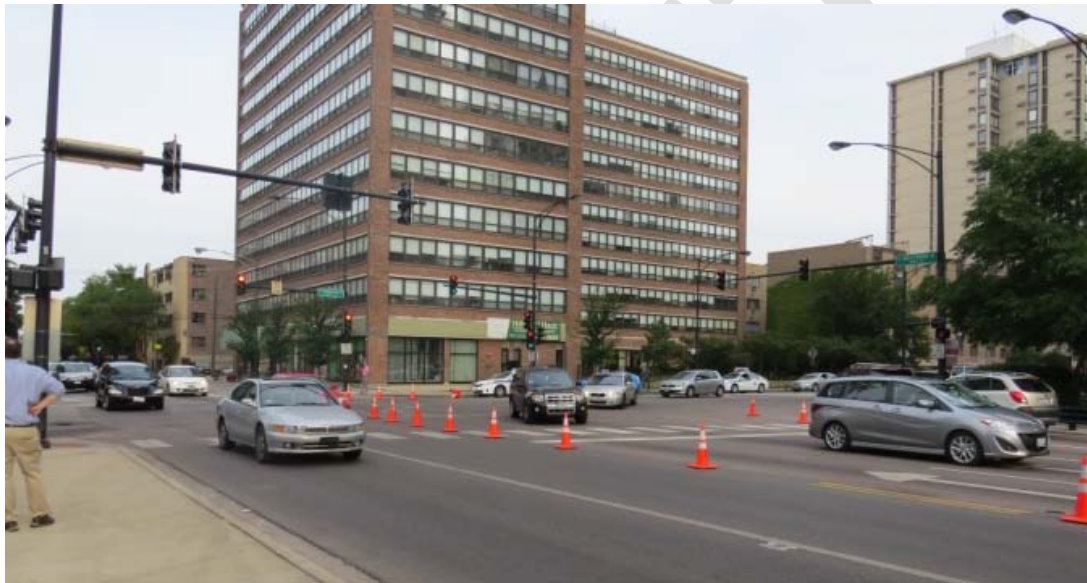
To accommodate traffic volumes of this magnitude while minimizing congestion, a manual traffic management operation has been instituted by CDOT in the weekday morning peak period at the Hollywood/Sheridan/NLSD intersection in concert with special traffic signal phasing. This manual traffic management operation employs traffic cones and unconventional signal phasing where southbound to eastbound left turns flow at the same time as eastbound through vehicles.

The southbound left turns are routed in the wrong direction onto northbound NLSD via a temporary reversible lane configuration on mainline Lake Shore Drive north of Bryn Mawr before crossing over to the southbound lanes. North/westbound traffic on Lake Shore Drive approaching this intersection is forced into a single right turn lane onto northbound Sheridan Road. The northbound queue on Lake Shore Drive due to the lane reduction can extend all the way to Foster Avenue at times. When the queue reaches the Bryn Mawr exit ramp, traffic begins to divert to Bryn Mawr, and then turns north at Sheridan or at Kenmore.

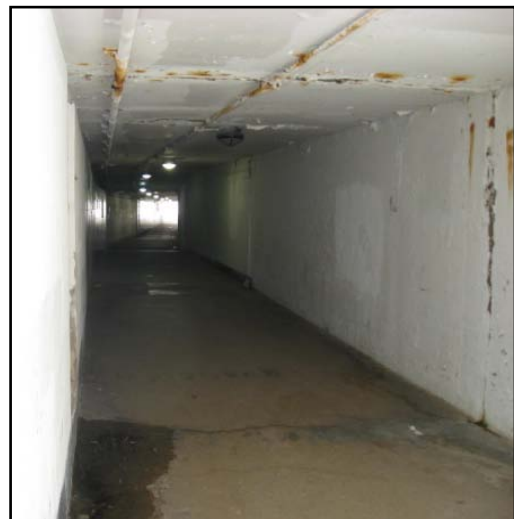
Because much of the NLSD infrastructure was constructed in the 1930s, bridges and pedestrian tunnels have exceeded their typical service lives by 30 or more years. Regular cycles of maintenance and rehabilitation have been successful in extending their service lives; however, maintenance cycles are becoming more frequent and can no longer address many of the underlying issues. As detailed on Exhibit 7, two of the eleven roadway structures (the Wilson Avenue and Lawrence Avenue overpasses) are in poor condition and thus would be considered structurally deficient. Pedestrian tunnels at the Michigan Avenue/Oak Street intersection are also in poor condition and are considered structurally deficient.

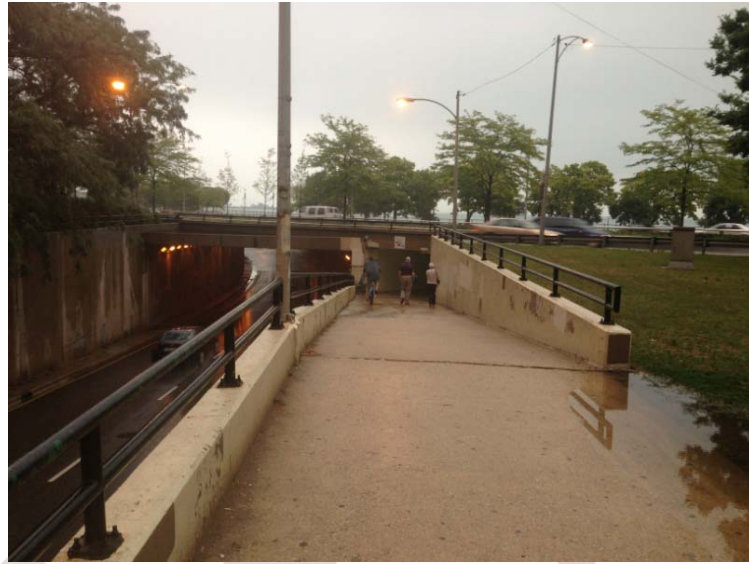
Many of the pedestrian tunnels that provide access to Lincoln Park are undersized for current park user demands, flood during heavy rain falls and do not meet ADA requirements for handicapped accessibility (see Exhibit 7). Several tunnels have blind corners and sight distance restrictions at entries.

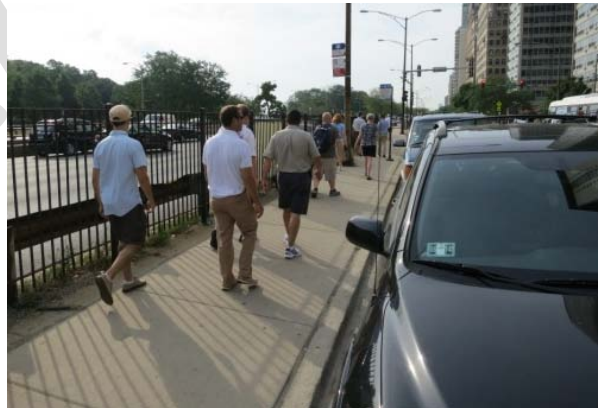
Northbound bus stops on the Inner Drive north of Belmont Avenue are squeezed onto the narrow 10-foot wide medians between the Inner and Outer Drives. Bus riders stand only a few feet away from high speed traffic on the Outer Drive, protected only by a guardrail and a Plexiglas splash-shield. There are no northbound bus stops provided on the Inner Drive between Grand Avenue and Oak Street because the median or barrier wall that separates the Inner Drive from the Outer Drive is too narrow.

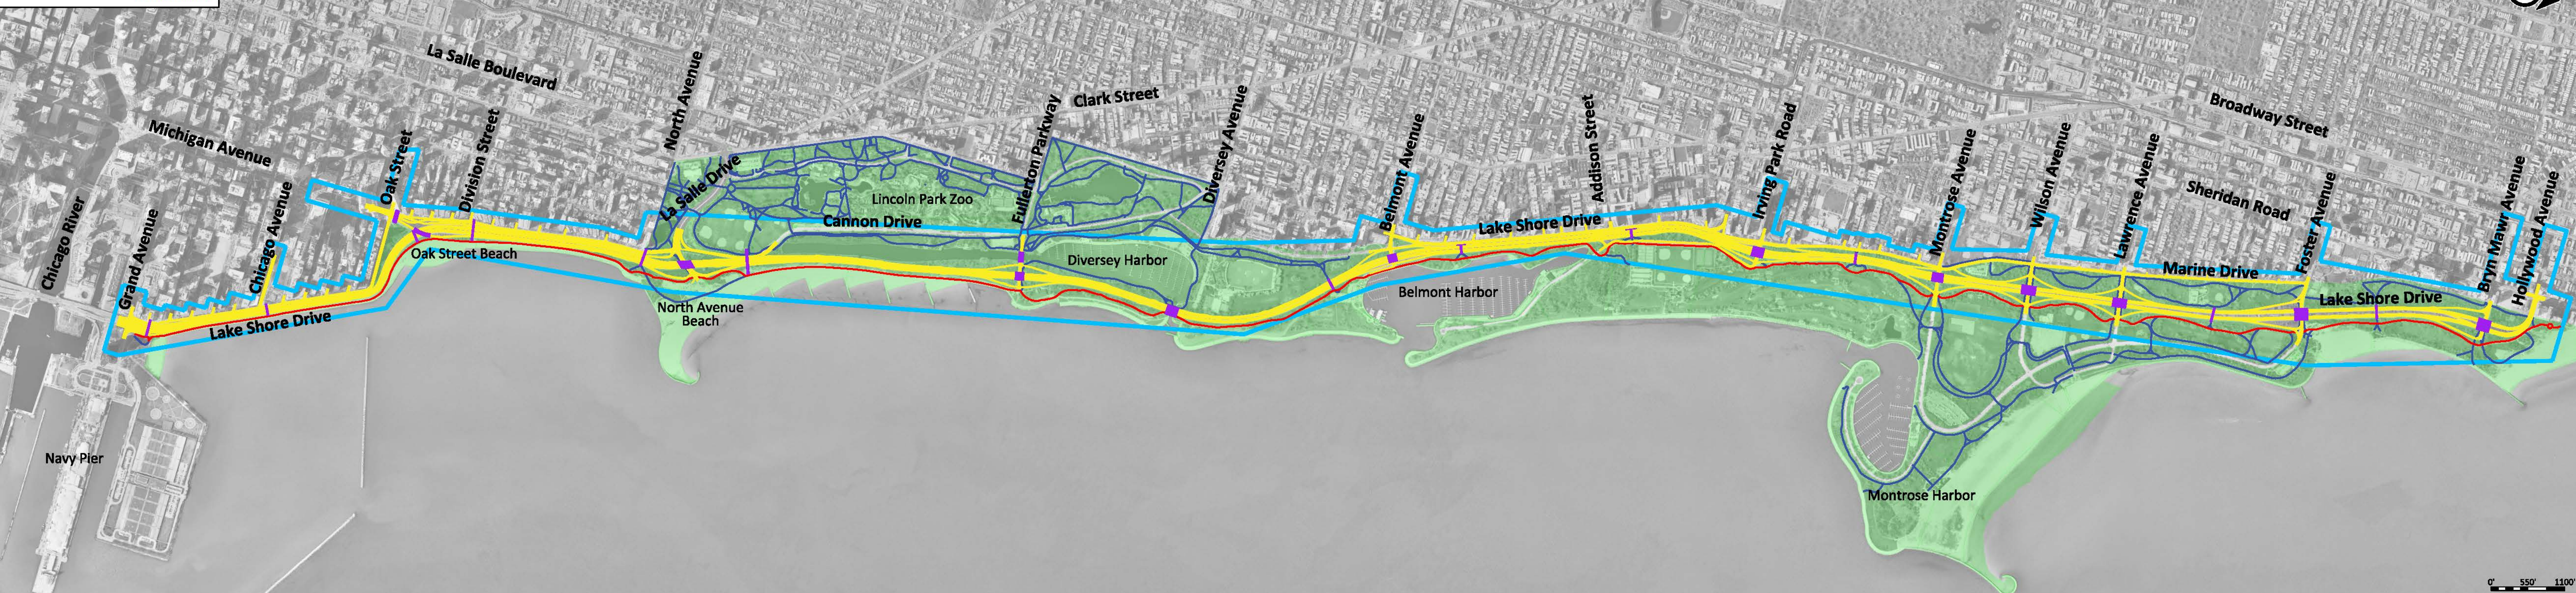
The NLSD study area is depicted on Exhibit 2. The study area encompasses the seven-mile multi-modal transportation corridor and includes the parallel Inner Drive roadways as well as crossing arterial streets and the Lakefront Trail.

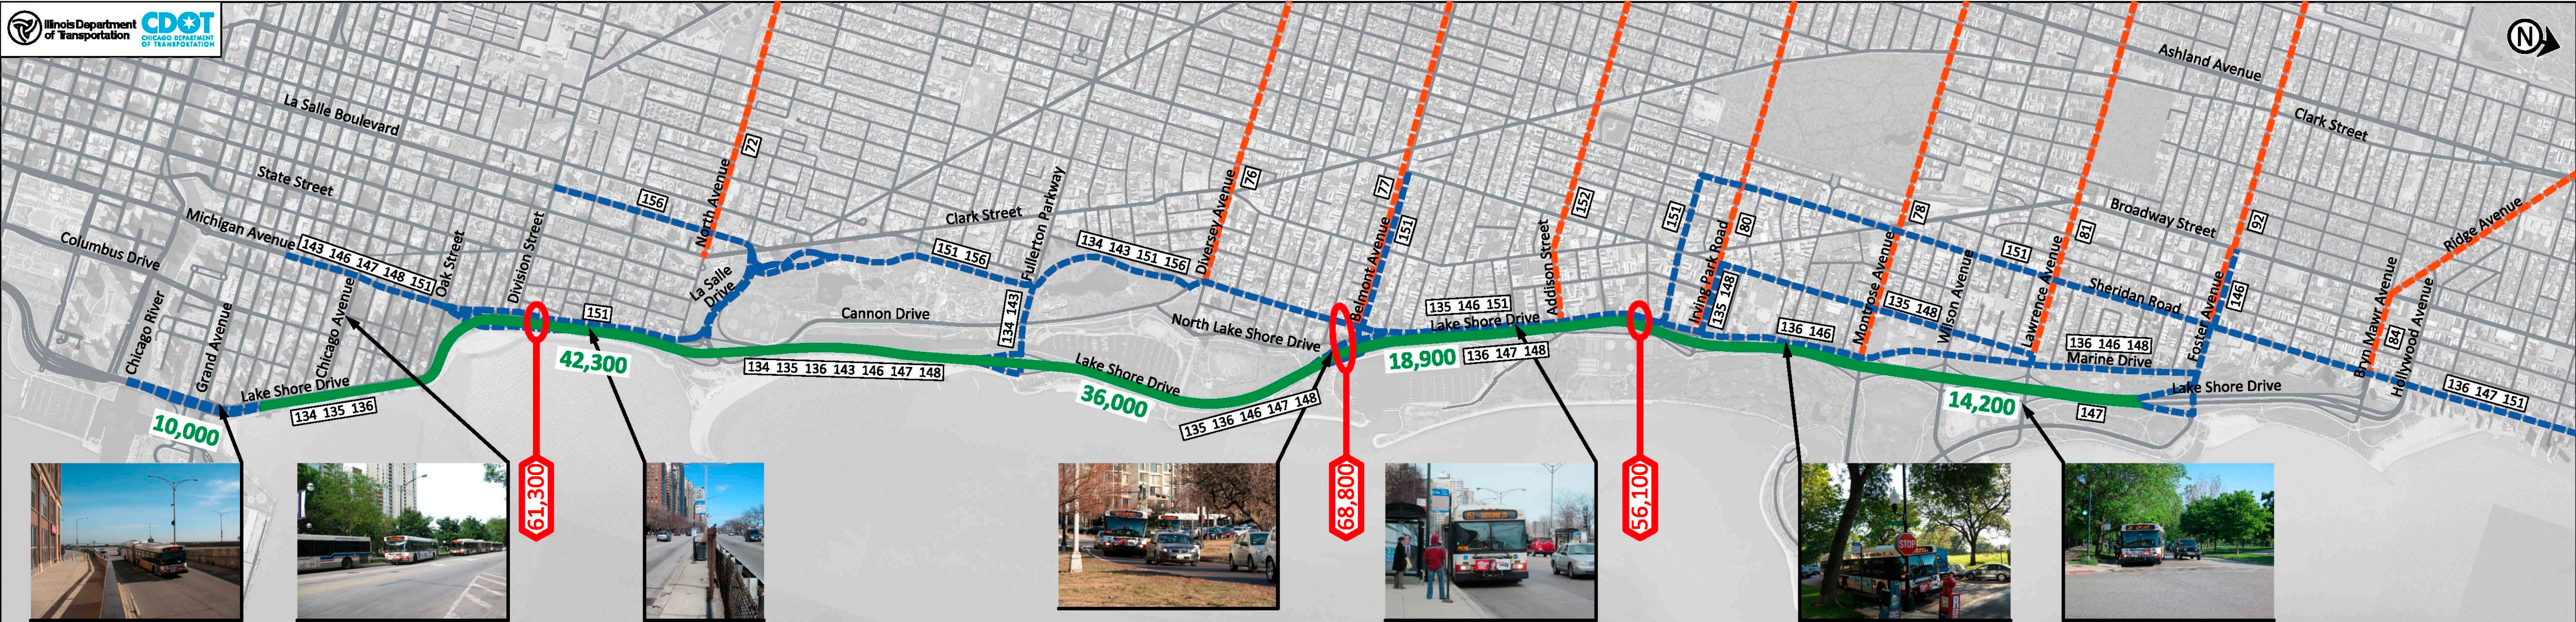
North Lake Shore Drive Phase I Study  
**Existing Weekday Transit Ridership**

<b>XXX</b>	Bus Route Number	<b>XX,XXX</b>	NLSD Average Daily Weekday Transit Ridership
<b>—</b> (Green)	N/S Express Bus Route	<b>XX,XXX</b> (Red)	Average Weekday Total Corridor Transit Ridership
<b>—</b> (Blue)	N/S Local Bus Route		
<b>—</b> (Orange)	E/W Local Bus Route

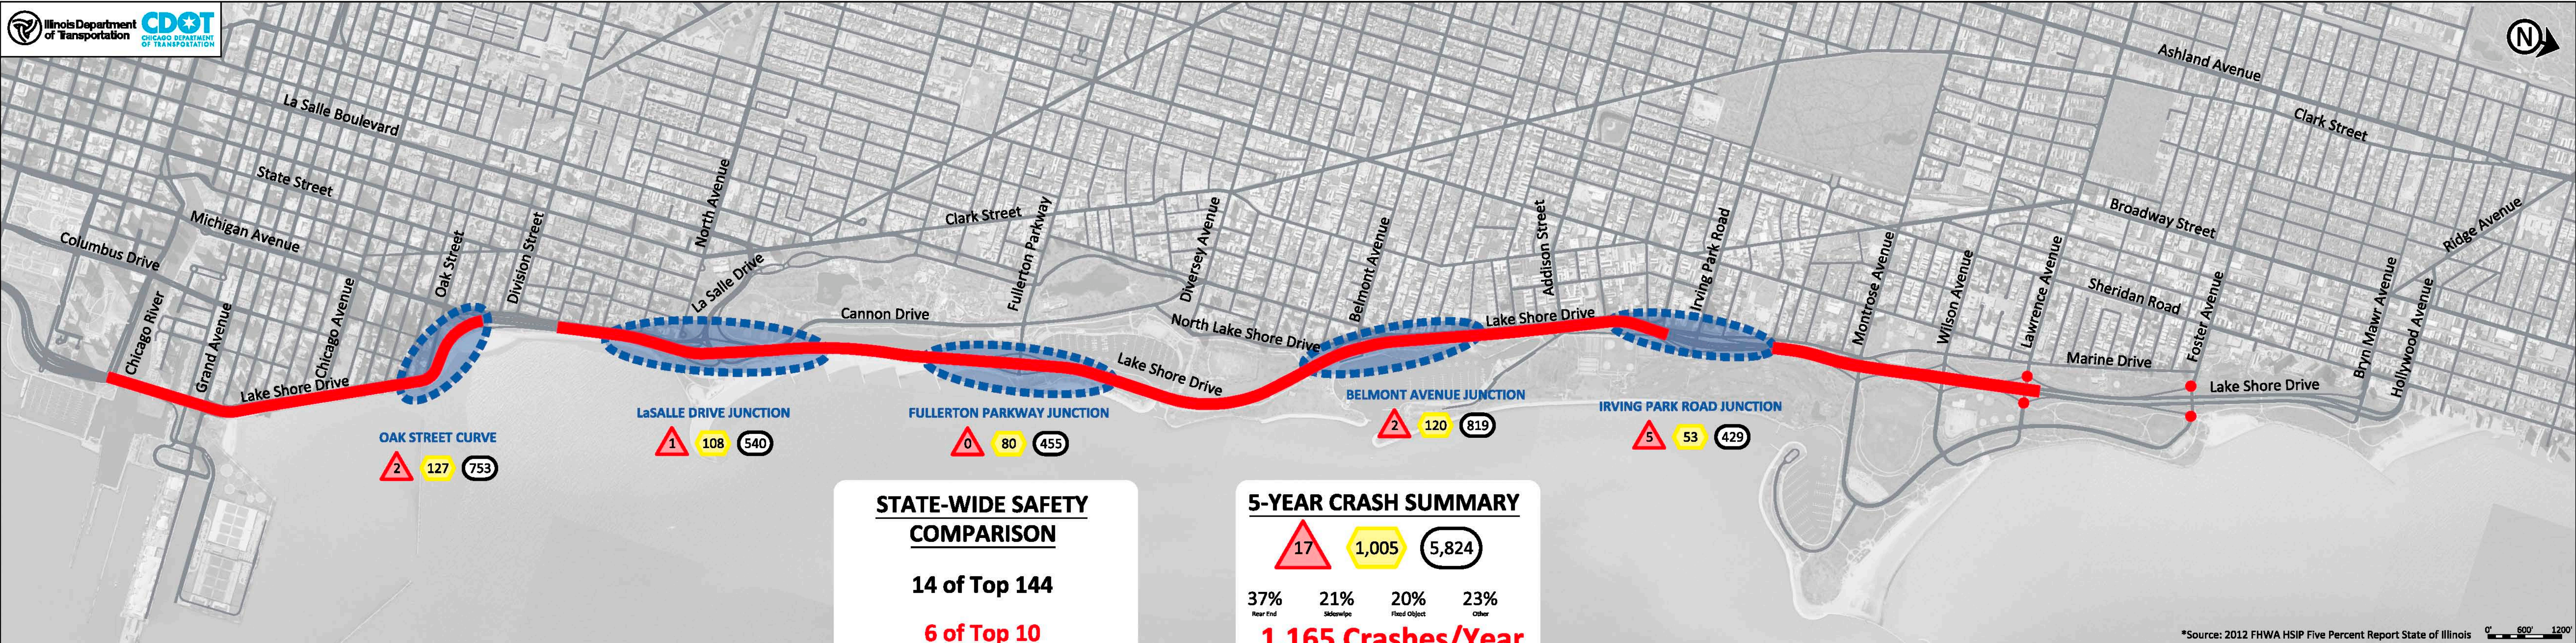
North Lake Shore Drive Phase I Study  
**2007-2011 Crash Data\***

**STATE-WIDE SAFETY COMPARISON**

**14 of Top 144**
