1.0 Purpose of and Need for Action

North Lake Shore Drive Phase I Study

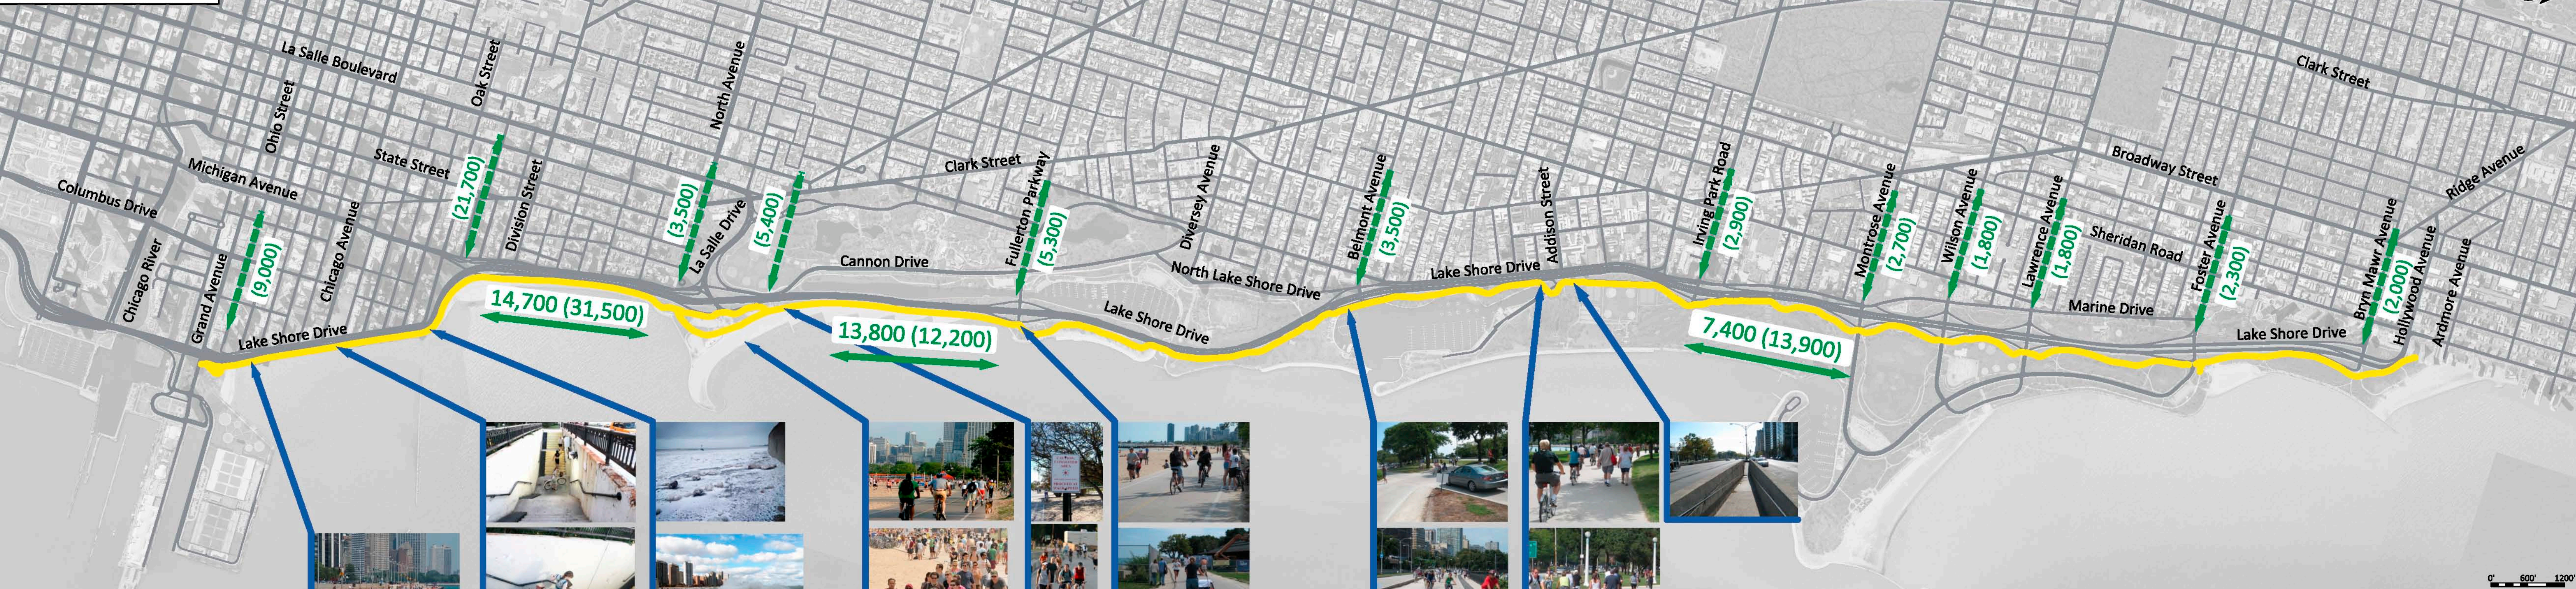
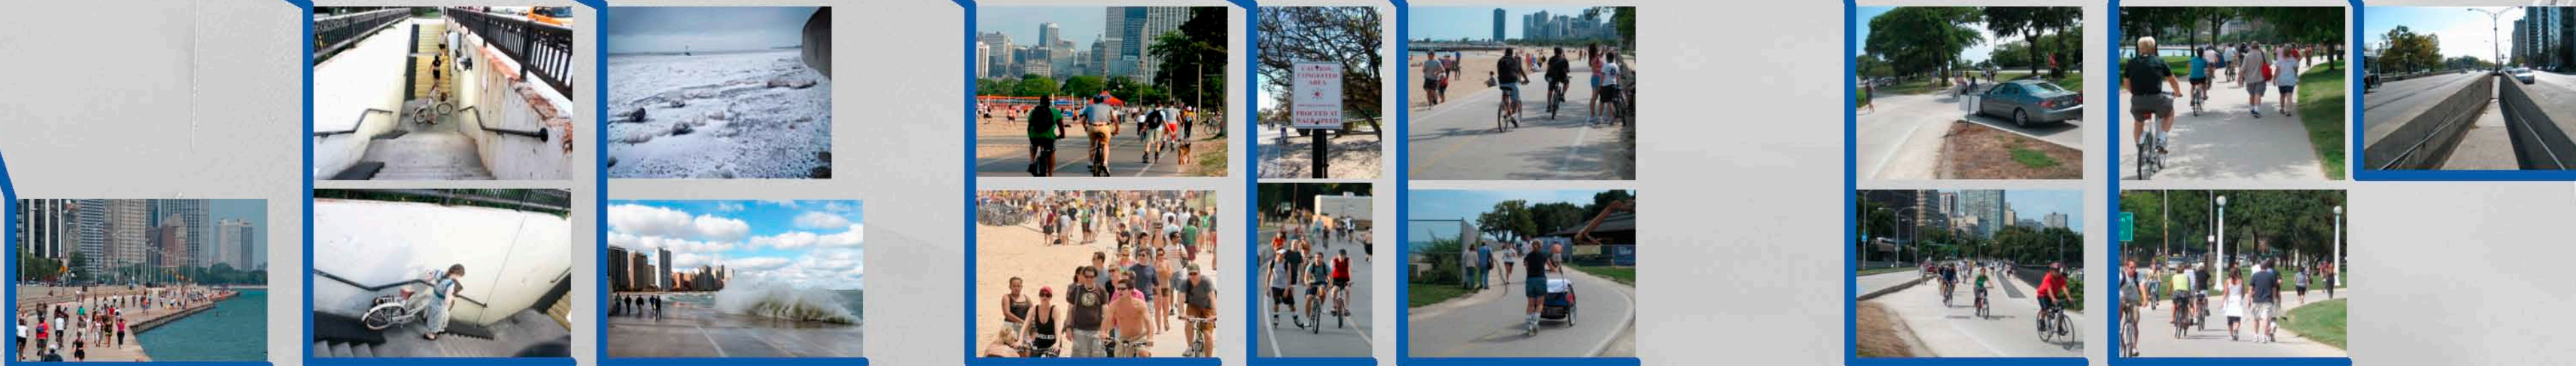
█ Lakefront Trail
↔ Two-way Park Entrance Counts⁽¹⁾
↔ Two Way Trail Counts⁽²⁾

XX,XXX Weekday Daily Trail Volume⁽¹⁾
(XX,XXX) Weekend Daily Trail Volume⁽¹⁾
(1) Bicycles, Pedestrians, and Others
(2) Source: Lakefront Trail Counts June - August 2013

Lincoln Park draws as many as 20 million visitors each year. The Lakefront Trail is heavily used for recreation, tourism and commuting, with peak Saturday trail utilization between 7,700 users per day north of Hollywood Avenue to more than 31,000 users per day at Oak Street as shown on Exhibit 5.

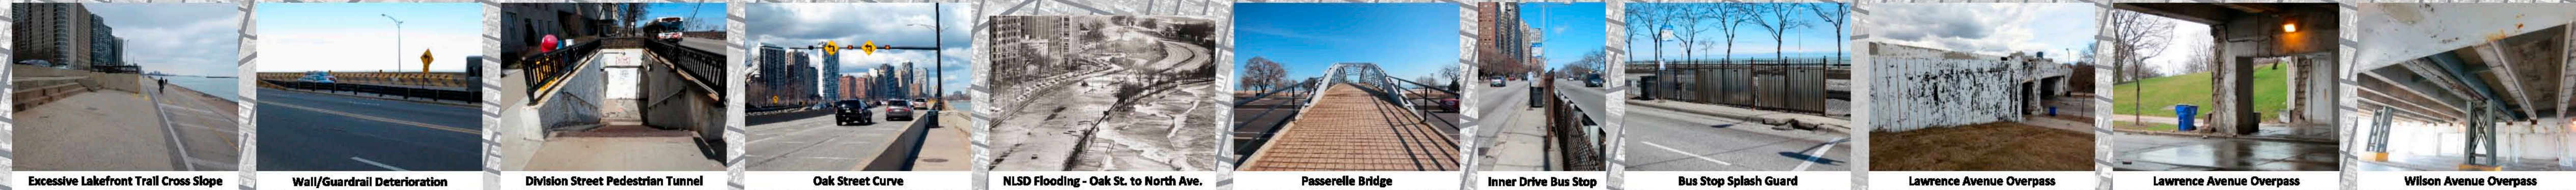
North Lake Shore Drive Phase I Study
Existing Infrastructure Conditions

Notes:
 * Structure Condition is based on lowest condition rating for Deck, Superstructure, and Substructure.
 ** ADA Compliance applies to structure and approach pathways.

Structure Location	Structure Condition*	Structure Appraisal	ADA Compliance**	Shoreline Protection
	Good	Meets Standards	Meets ADA Requirements	Roadway/Lakefront Trail Flooding
	Fair	Structurally Deficient	Does not meet ADA Requirements	Deteriorated Shoreline Revetment
	Poor	Functionally Obsolete

evaluating structure components (e.g. bridge deck, superstructure and substructure components of bridges). For the purposes of Exhibit 7, a single condition rating was presented for each structure which coincided the lowest rating given to any one of the individual structure components.

The structure condition rating was then combined with an evaluation of the functional adequacy of the structure to develop a **Structure Appraisal Rating**. The Structure Appraisal Rating falls into one of three categories: *Meets Standards*, *Functionally Obsolete* or *Structurally Deficient*. The functional adequacy of structures was determined by examining geometric standards for widths and clearances alongside peak motorized and/or non-motorized user demands. Structures which did not meet current standards for deck geometry, load carrying capacity, clearance or approach roadway alignment or which could not adequately serve user demands were judged to be functionally obsolete.

Bridges were classified as structurally deficient where significant load carrying elements were rated to be in *poor* or worse condition due to deterioration or damage. It should be noted that any structure classified as structurally deficient was excluded from the functionally obsolete category as structures that are both structurally deficient and functional obsolete are reported together as deficient structures.
