1.0 Purpose of and Need for Action

The North Lake Shore Drive (NLS D) study corridor extends approximately seven miles from Grand Avenue to Hollywood Avenue. See Exhibits 1 and 2 in Appendix A. The corridor is comprised of the eight-lane “Outer Drive” boulevard and the parallel two to four-lane “Inner Drive” local access roadway that is variously named North Lake Shore Drive, Sheridan Road and Marine Drive. The Outer Drive is designated as US 41 from the south study limit to Foster Avenue, where the US route designation continues west on Foster. The Outer Drive between Foster Avenue and the northern terminus at Hollywood Avenue is an unmarked State route. The Outer Drive is on the National Highway System which consists of roadways that are important to the nation’s economy, defense and mobility.

North Lake Shore Drive Phase I Study

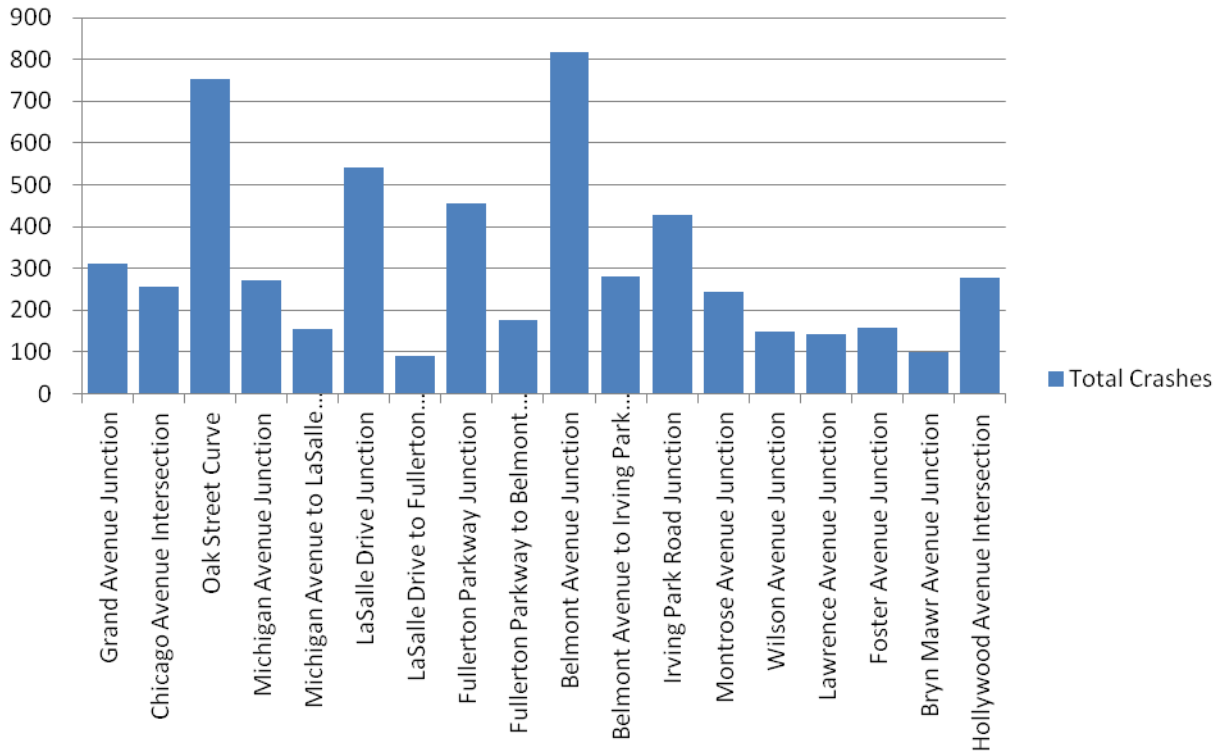
Chart 1
North Lake Shore Drive
Schematic Crash Summary

Chart 1 depicts crash data by location.

Although vehicle crashes are dispersed throughout the corridor, the following five locations have substantial crash histories that account for 51% of the total crashes during the study period as well as two-thirds of the crashes that occurred at junctions and intersections:

- Oak Street Curve (753 crashes)
- LaSalle Drive Junction (540 crashes)
- Fullerton Parkway Junction (455 crashes)
- Belmont Avenue Junction (819 crashes)
- Irving Park Road Junction (429 crashes)

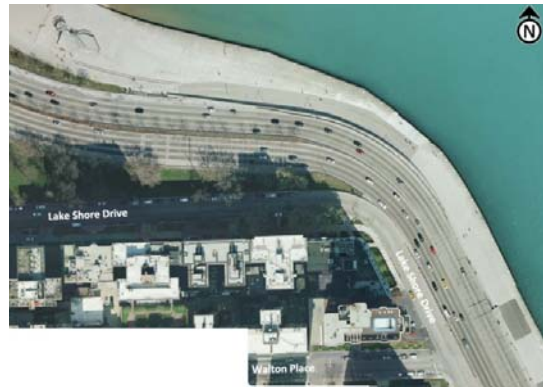
Oak Street Curve - Fifty-six percent of the crashes on the Oak Street curve were off-road fixed object collisions with the barrier walls that line the curve. Of all of the crashes on the curve, 76% occurred during wet or icy conditions. The maximum safe operating speed on the Oak Street curve under ideal conditions is 30 mph (25 mph posted advisory speed), which is substantially lower than the prevailing speeds of traffic. Despite the geometric limitations of the Oak Street curve and the 40 mph posted speed limit, hourly 85th percentile speeds immediately north and south of the curve have been measured to be as high as 68 mph. Compounding the challenge of negotiating the curve is the fact that lane widths on the Outer Drive are only 10 feet wide on the curve.

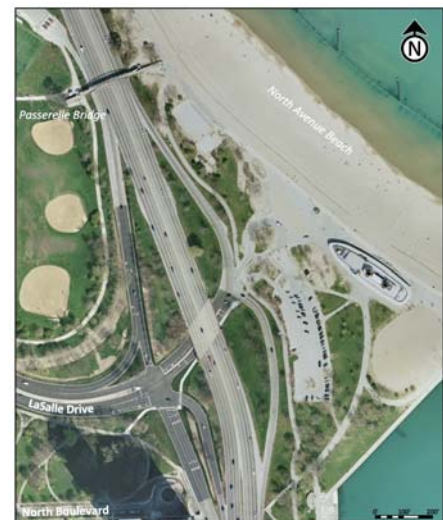
The next most predominant crash type at this junction was the off-road fixed object collision, of which 80 of 114 crashes occurred on southbound NLSJ immediately south of the LaSalle Drive overpass. The concentration of fixed object crashes at this location would indicate a potential problem with the combination of horizontal and vertical roadway alignment south of the bridge and high vehicle speeds. Even though the posted speed limit is 40 mph, the free-flow hourly 85th percentile southbound vehicle speeds measured along this section of NLSJ averaged 58 mph.

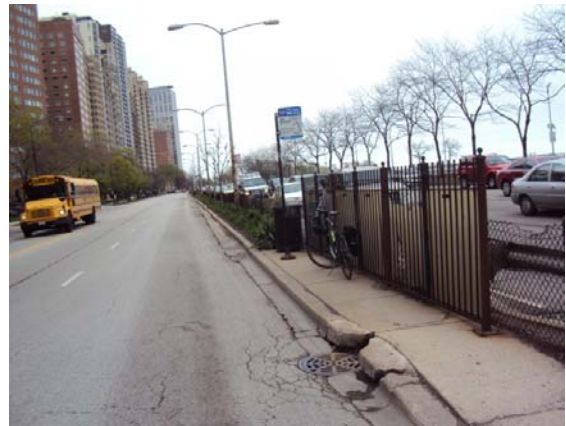
Northbound bus stops on the Inner Drive north of Belmont Avenue are squeezed onto the narrow 10-foot wide medians between the Inner and Outer Drives. Bus riders stand only a few feet away from high speed traffic on the Outer Drive, protected only by a guardrail and a Plexiglas splash-shield. There are no northbound bus stops provided on the Inner Drive between Grand Avenue and Oak Street because the median or barrier wall that separates the Inner Drive from the Outer Drive is too narrow.

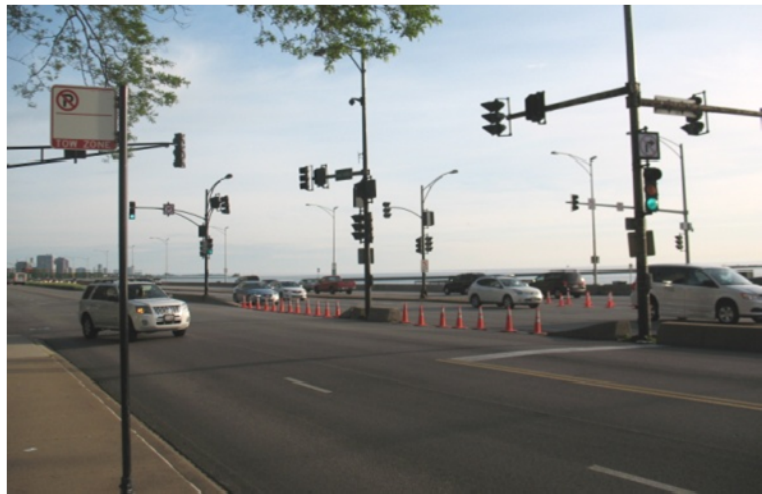
Chicago Avenue, which is the only signalized intersection on NLSD, causes substantial mainline congestion, especially northbound during the P.M. peak period. Northbound queues can extend nearly to Monroe Street, which is about one mile to the south. Southbound queues in the afternoon can extend as far as the Michigan Avenue exit ramp, nearly ¾-mile to the north. Eastbound Chicago Avenue experiences long vehicle queues during the P.M. peak period as well. The intersection LOS in the P.M. peak hour is Level “F” (average delay = 2.2 minutes/vehicle).

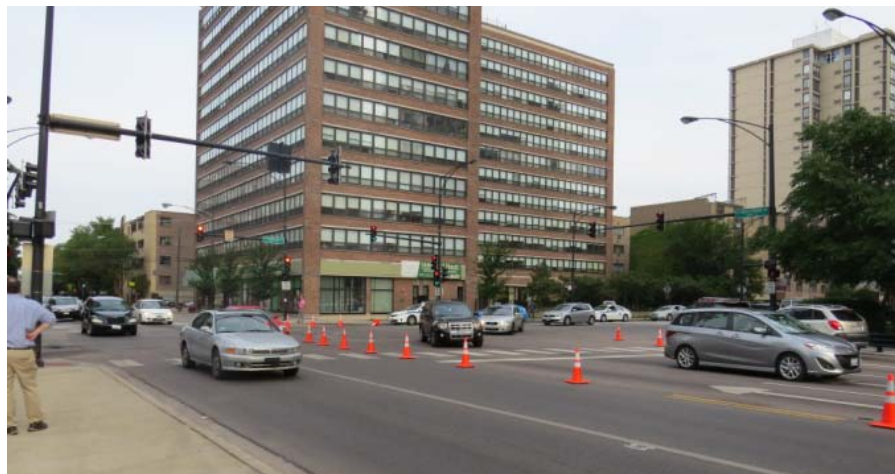
To accommodate traffic volumes of this magnitude while minimizing congestion, a manual traffic management operation has been instituted by CDOT in the weekday morning peak period at the Hollywood/Sheridan/NLSL intersection in concert with special traffic signal phasing. This manual traffic management operation employs traffic cones and unconventional signal phasing where southbound to eastbound left turns flow at the same time as eastbound through vehicles.

The southbound left turns are routed in the wrong direction onto northbound NLSL via a temporary reversible lane configuration on mainline Lake Shore Drive north of Bryn Mawr before crossing over to the southbound lanes. North/westbound traffic on Lake Shore Drive approaching this intersection is forced into

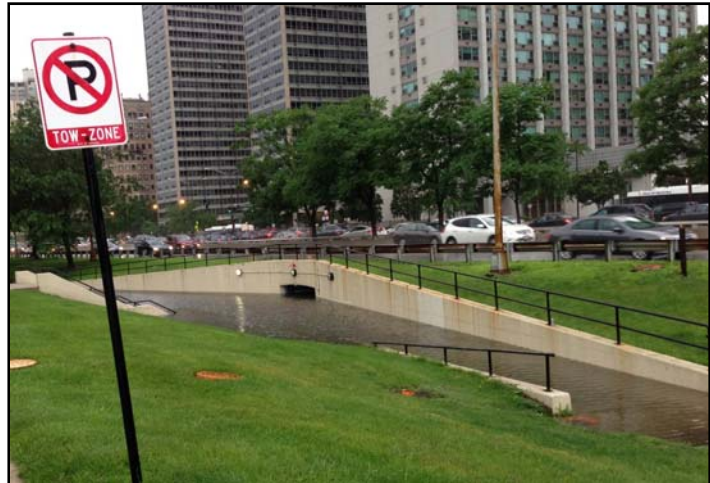
Flooding occurs as a result of large rain events and from high wave action on Lake Michigan. Most of NLSD drains into the City's combined sewer system, which cannot adequately accommodate heavy storm water flows and results in the flooding of underpasses and adjacent streets. Flooding impacts buses earlier and more often than other vehicles, and weather-related detours quite often require buses to navigate through congested streets, impacting and sometimes stranding thousands of transit commuters.

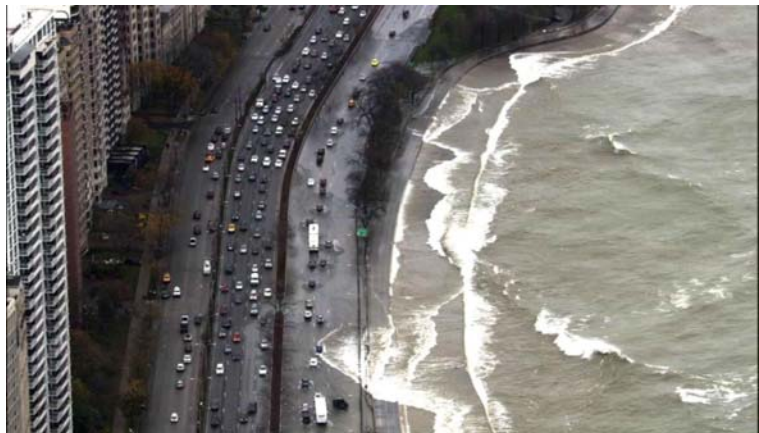
Due to the proximity of NLSD and the Lakefront Trail to Lake Michigan, they are subject to occasional flooding as a result of high wave action. This flooding causes hazardous conditions, particularly in the wintertime when the roadway and the Lakefront Trail can quickly become ice covered. Portions of the trail are impassible for extended periods of time due to ice buildup in the winter.

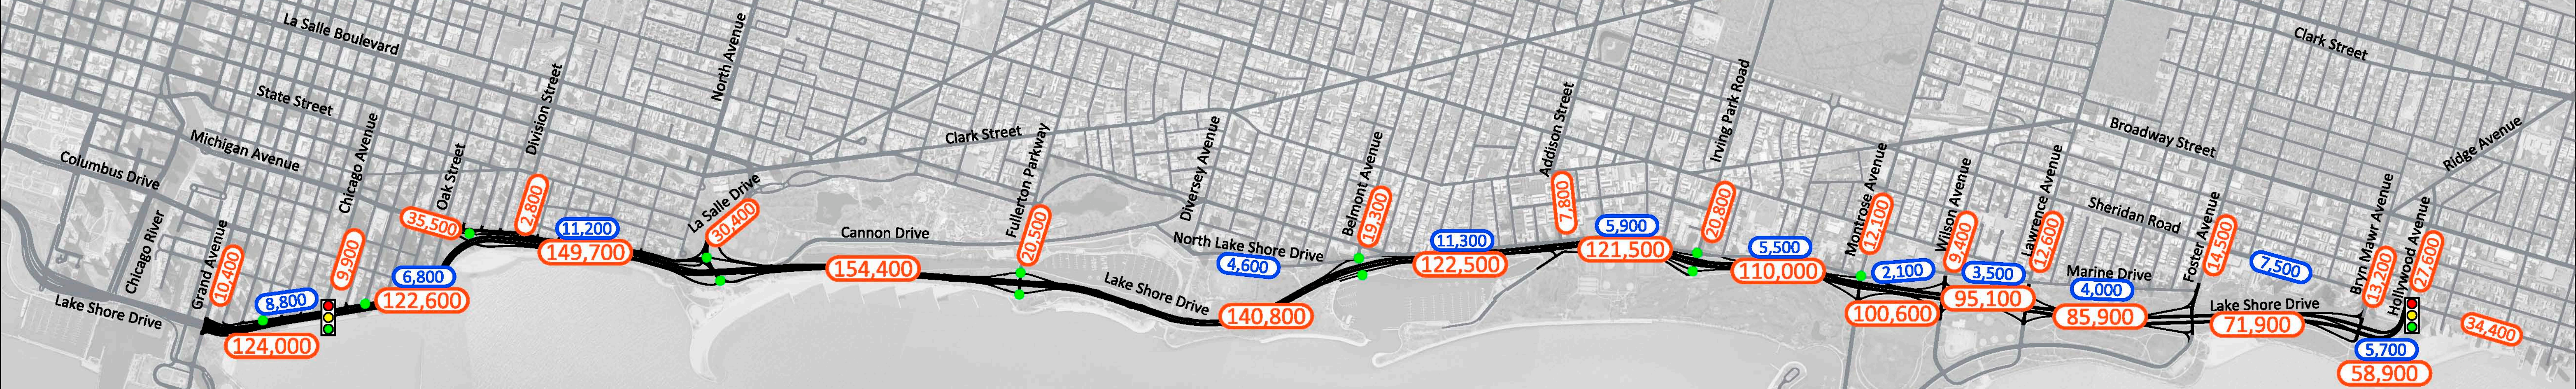
North Lake Shore Drive Phase I Study
Existing Average Daily Traffic
 January 2, 2014

XXX,XXX 2013 Average Daily Traffic Volume
X,XXX 2013 Average Daily Traffic Volume (Inner Lake Shore Drive, Marine Drive, Sheridan Road)
 Existing North Lake Shore Drive Traffic Mainline Signal
 Existing North Lake Shore Drive Junction Ramp Signal

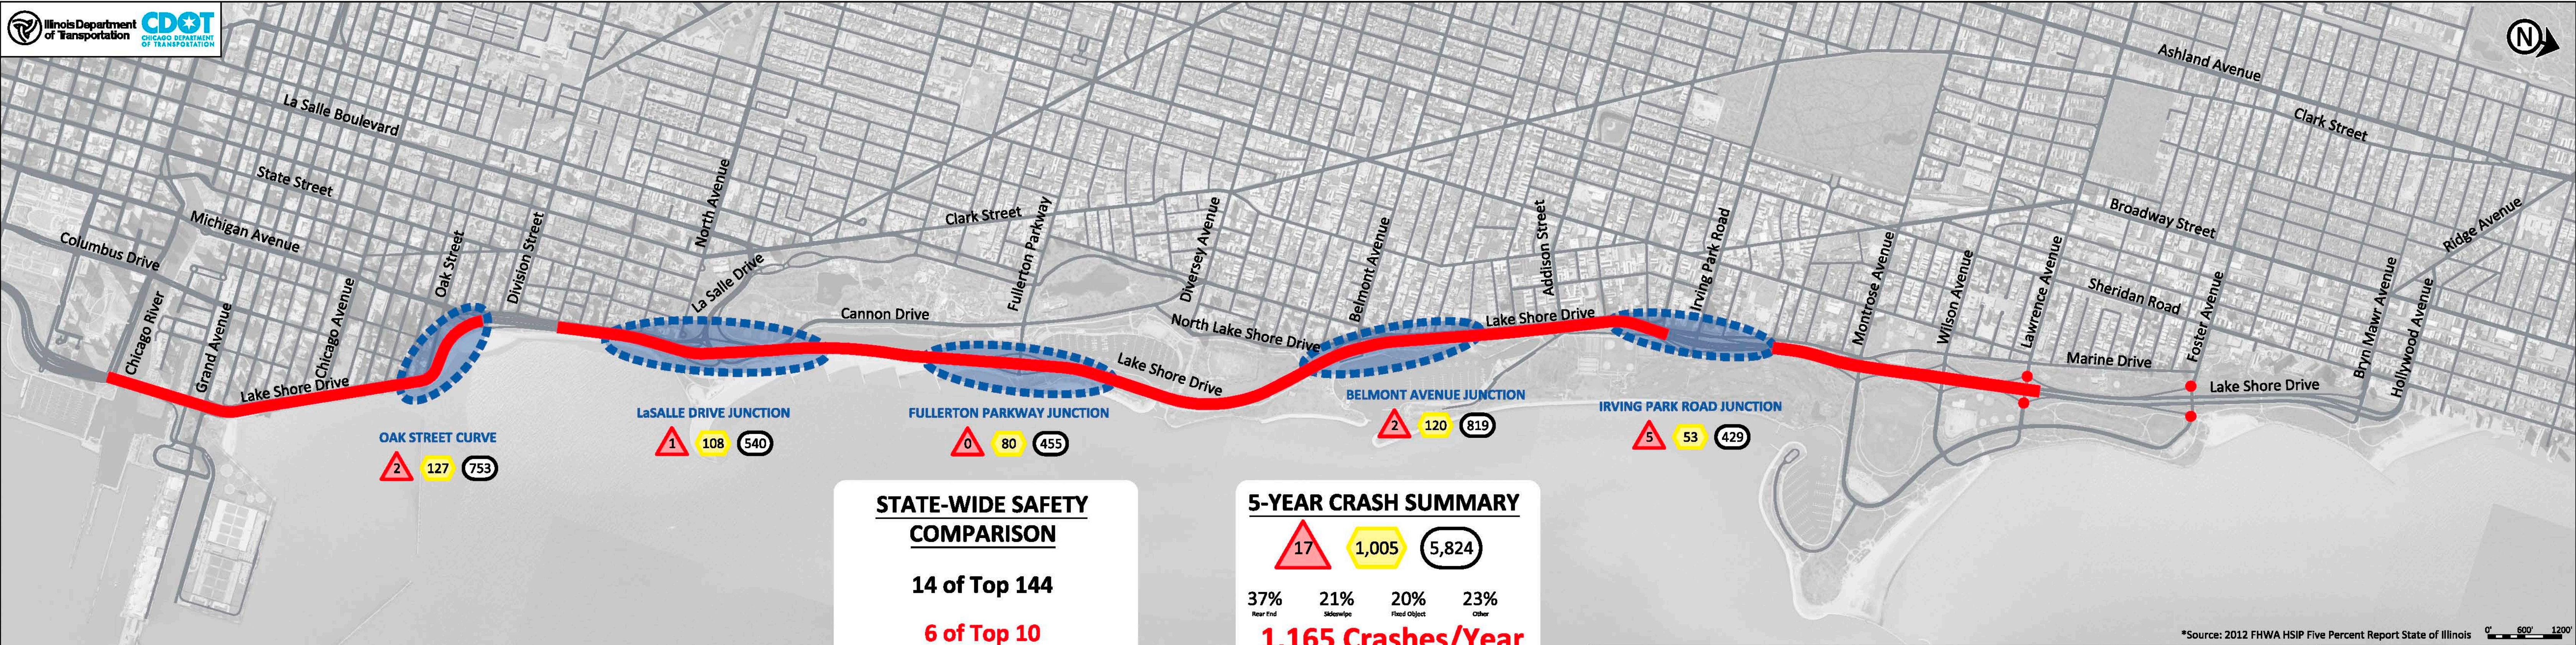
North Lake Shore Drive Phase I Study
Existing Infrastructure Conditions

Notes:
 * Structure Condition is based on lowest condition rating for Deck, Superstructure, and Substructure.
 ** ADA Compliance applies to structure and approach pathways.

Structure Location	Structure Condition*	Structure Appraisal	ADA Compliance**	Shoreline Protection
	Good	Meets Standards	Meets ADA Requirements	Roadway/Lakefront Trail Flooding
	Fair	Structurally Deficient	Does not meet ADA Requirements	Deteriorated Shoreline Revetment
	Poor	Functionally Obsolete

Structure condition ratings were obtained directly from the latest Structure Condition Reports or, where Structure Condition Reports did not exist (i.e. for some pedestrian tunnels), they were developed from visual inspections of structures conducted in 2013. Ratings comply with FHWA rating criteria for evaluating structure components (e.g. bridge deck, superstructure and substructure components of bridges). For the purposes of Exhibit 7, a single condition rating was presented for each structure which coincided the lowest rating given to any one of the individual structure components.

The structure condition rating was then combined with an evaluation of the functional adequacy of the structure to develop a **Structure Appraisal Rating**. The Structure Appraisal Rating falls into one of three categories: *Meets Standards*, *Functionally Obsolete* or *Structurally Deficient*. The functional adequacy of structures was determined by examining geometric standards for widths and clearances alongside peak motorized and/or non-motorized user demands. Structures which did not meet current standards for deck geometry, load carrying capacity, clearance or approach roadway alignment or which could not adequately serve user demands were judged to be functionally obsolete.

Bridges were classified as structurally deficient where significant load carrying elements were rated to be in *poor* or worse condition due to deterioration or damage. It should be noted that any structure classified as structurally deficient was excluded from the functionally obsolete category as structures that are both structurally deficient and functional obsolete are reported together as deficient structures.

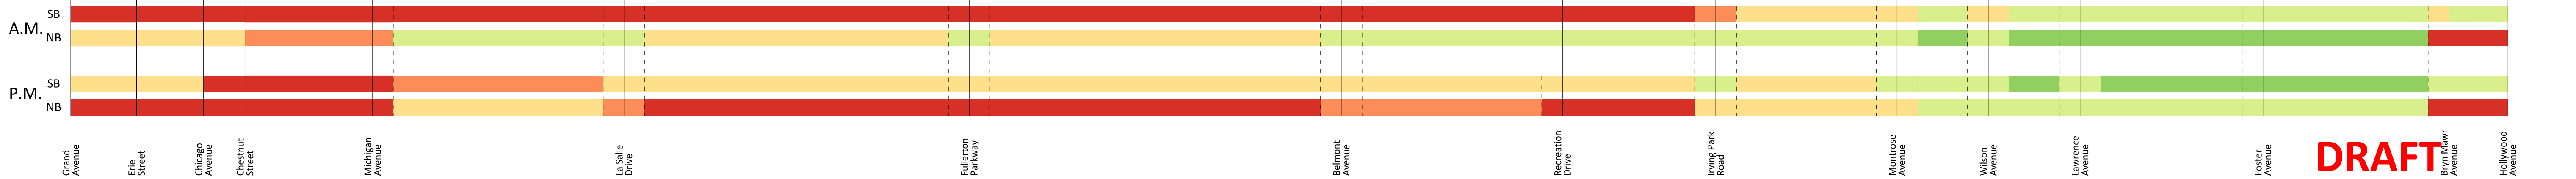
DRAFT
 North Lake Shore Drive Phase I Study
Intersection and Mainline Levels of Service
 with Traffic and Crash Data Overlay

Intersection	AM	PM	SAT
Grand Avenue	F 228	B 10	
Erie Street	C 22	F *	
Chicago Avenue	A 7	F 129	F 108
Chestnut Street	C 27	C 27	C 27
Michigan Avenue	C 28	D 35	C 26
LaSalle Drive	B 17	D *	A 7
Fullerton Parkway	C 10	D *	B 14
Belmont Avenue	F *	C 29	B 11
Recreation Drive	E 78	F 80	C 25
Irving Park Road	F 98	D 37	F 184
Montrose Avenue	B 13	B 12	B 10
Wilson Avenue	B 16	B 17	B 14
Lawrence Avenue	E 61	F 83	C 32
Foster Avenue	B 11	B 12	B 11
Bryn Mawr Avenue	D 47	F 88

Level of Service (LOS) is a congestion measure represented by six levels of service, ranging from A to F. LOS A represents the best (free flow) operating conditions and LOS F, the worst (breakdown) conditions. Exhibit 8 in Appendix A depicts Levels of Service at junction intersections as well as along the Outer Drive of NLSD.
