North Lake Shore Drive *Existing Conditions* INFRASTRUCTURE REPORT CARD

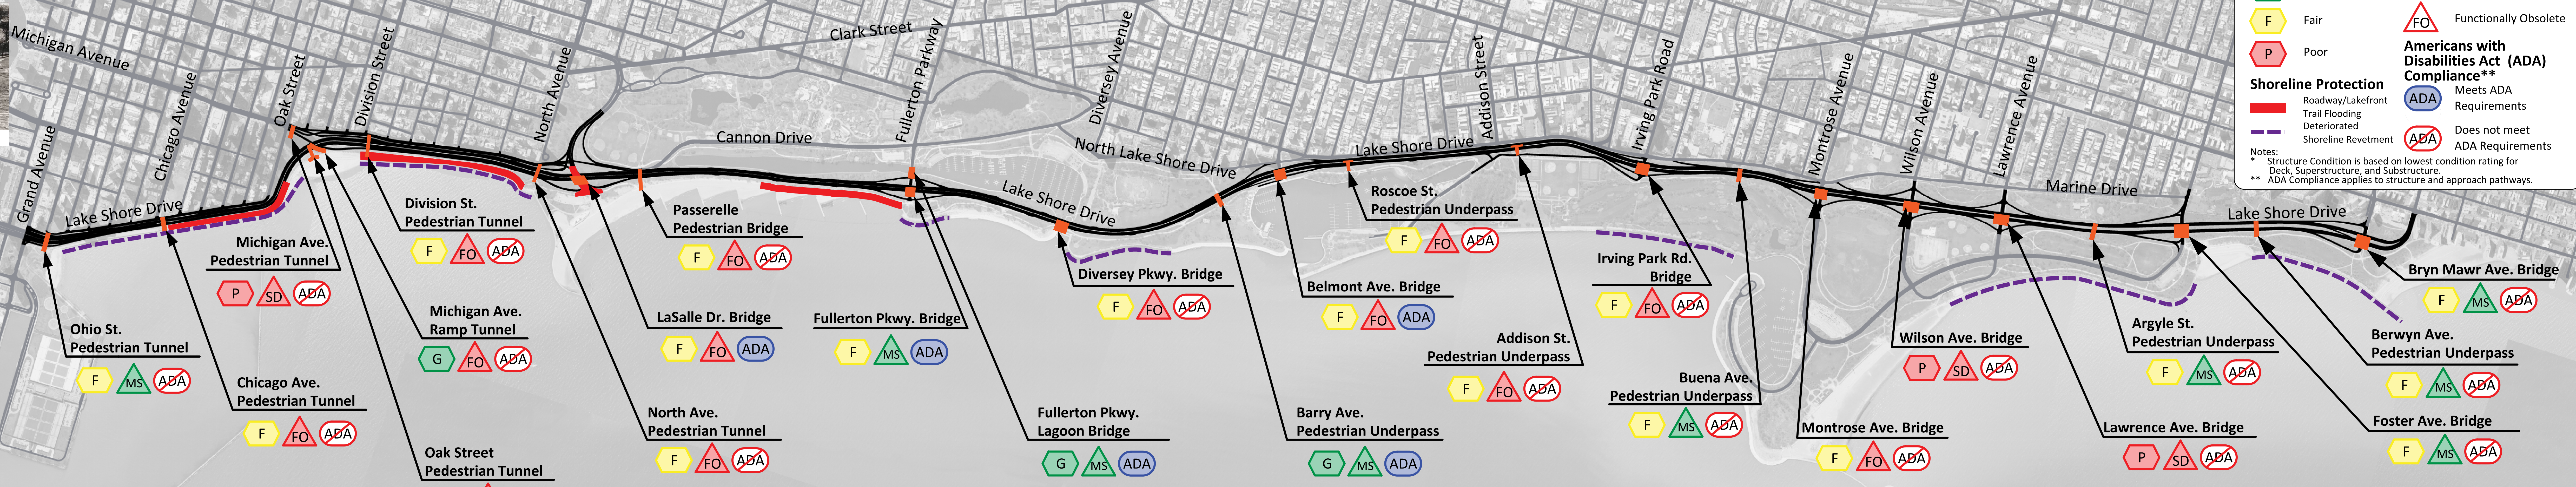
Notes:
* Structure Condition is based on lowest condition rating for Deck, Superstructure, and Substructure.
** ADA Compliance applies to structure and approach pathways.

Definitions
Structurally Deficient - important load carrying elements were rated to be in poor or worse conditions due to deterioration or damage.
Functionally Obsolete - do not meet current standards for deck geometry, load carrying capacity, clearance or approach roadway alignment or which could not adequately serve user demands.
