VIEW FROM INNER DRIVE

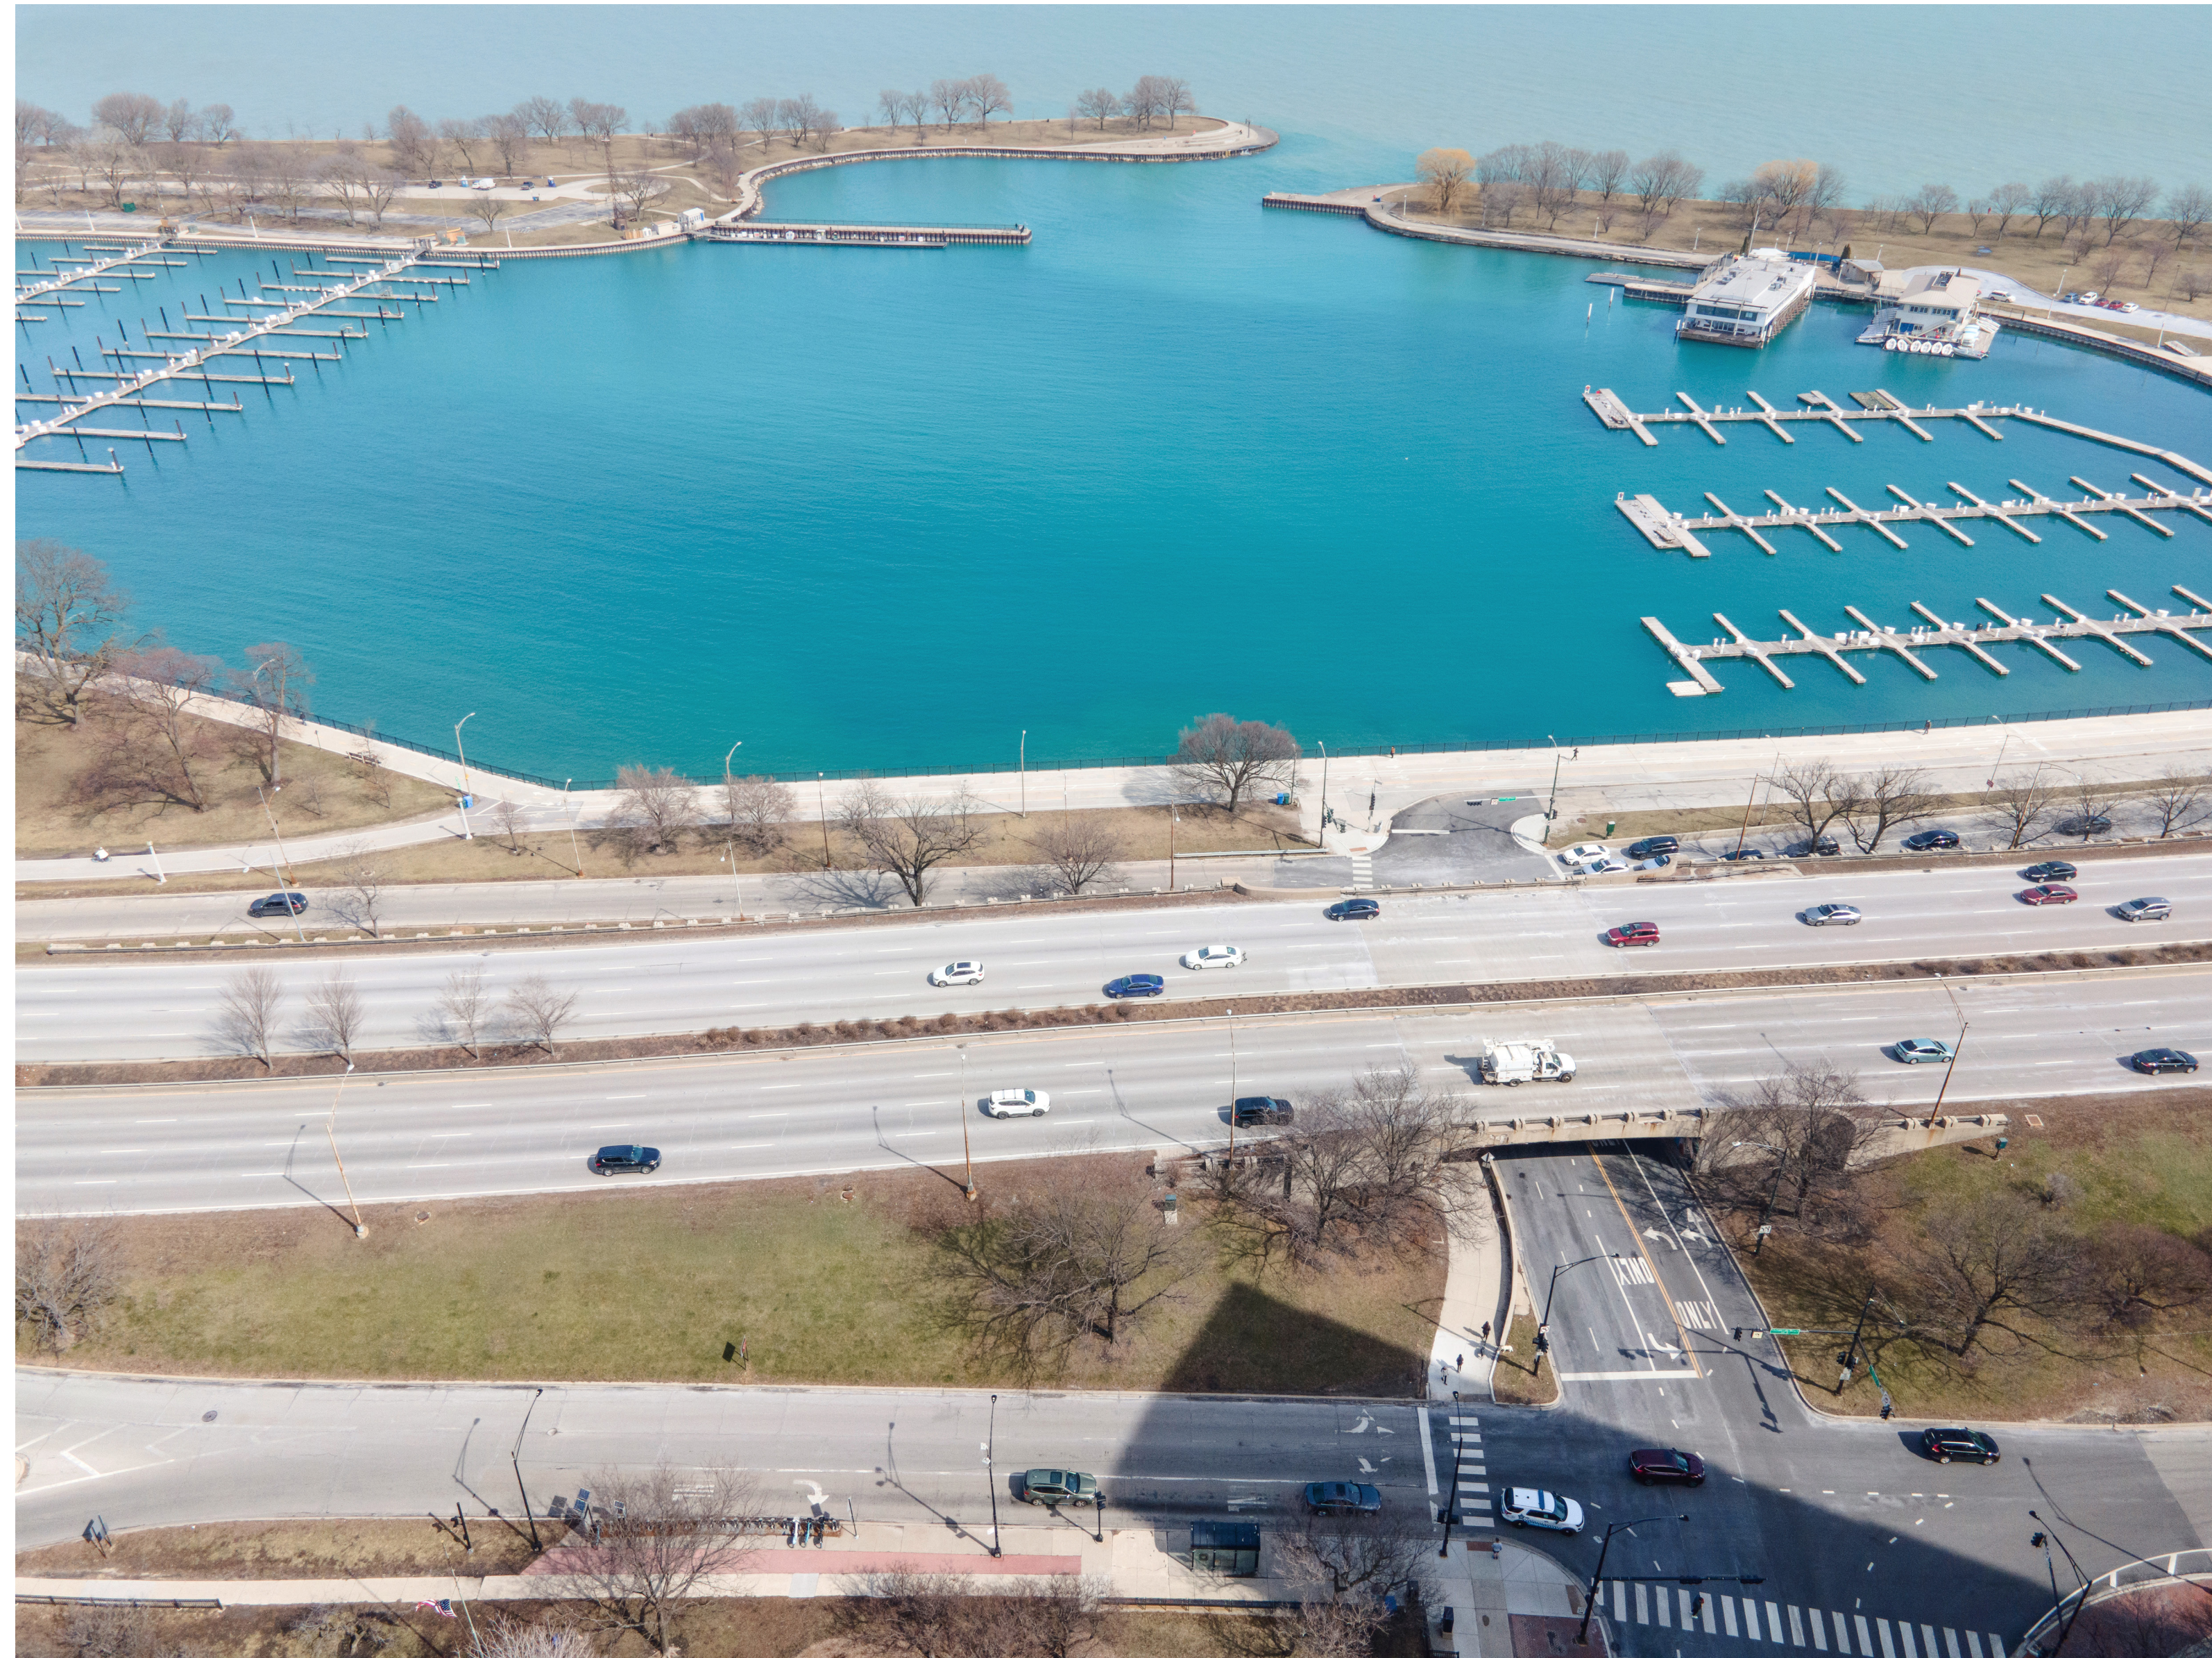
Existing Conditions

- Pedestrian access on North side of Belmont is narrow
- No dedicated space for bikes or transit
- Trail access point creates conflicts with cyclists and pedestrians
- Lack of space along harbor edge results in conflicts with trail users

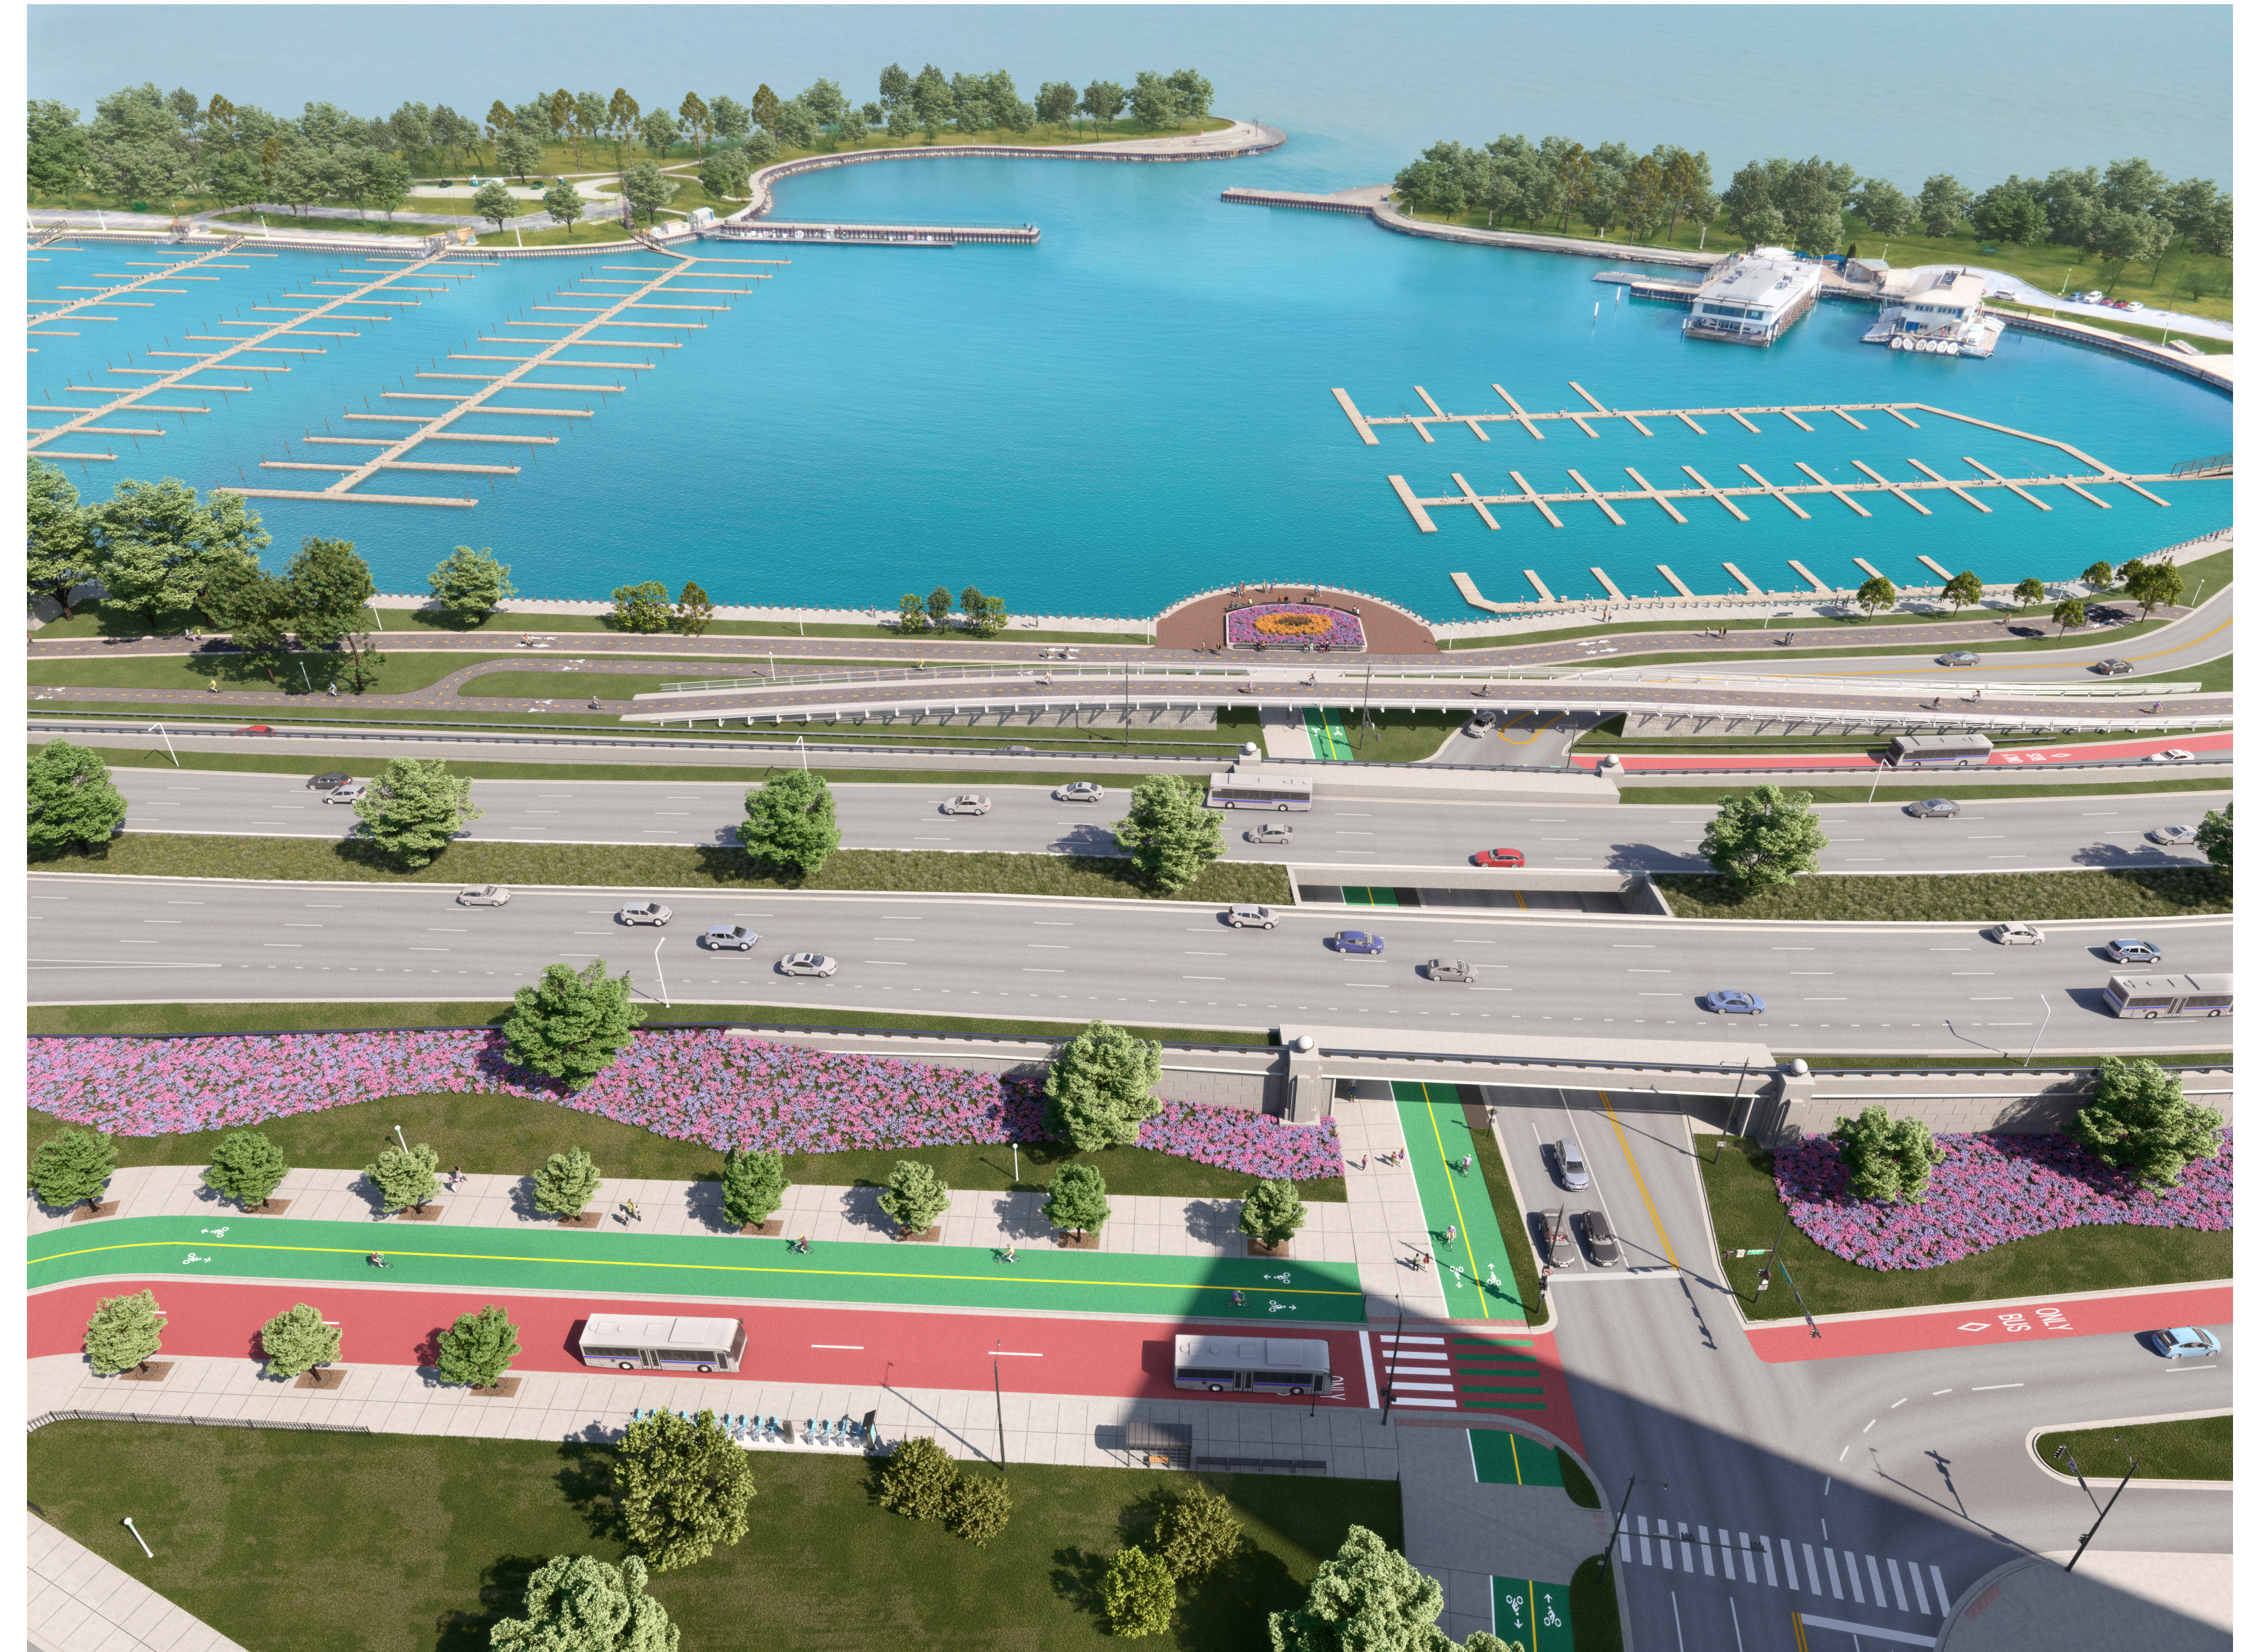
Potential Future Conditions

- Wide pedestrian access at Belmont provides space for off-street bike trails
- Bus only lanes provide dedicated transit space
- Trail access includes grade separated lakefront trail and overlook space
- New park space includes a lakefront promenade walk that is separate from recreational trails
