TYPICAL ROADWAY NORTH OF FULLERTON PARKWAY

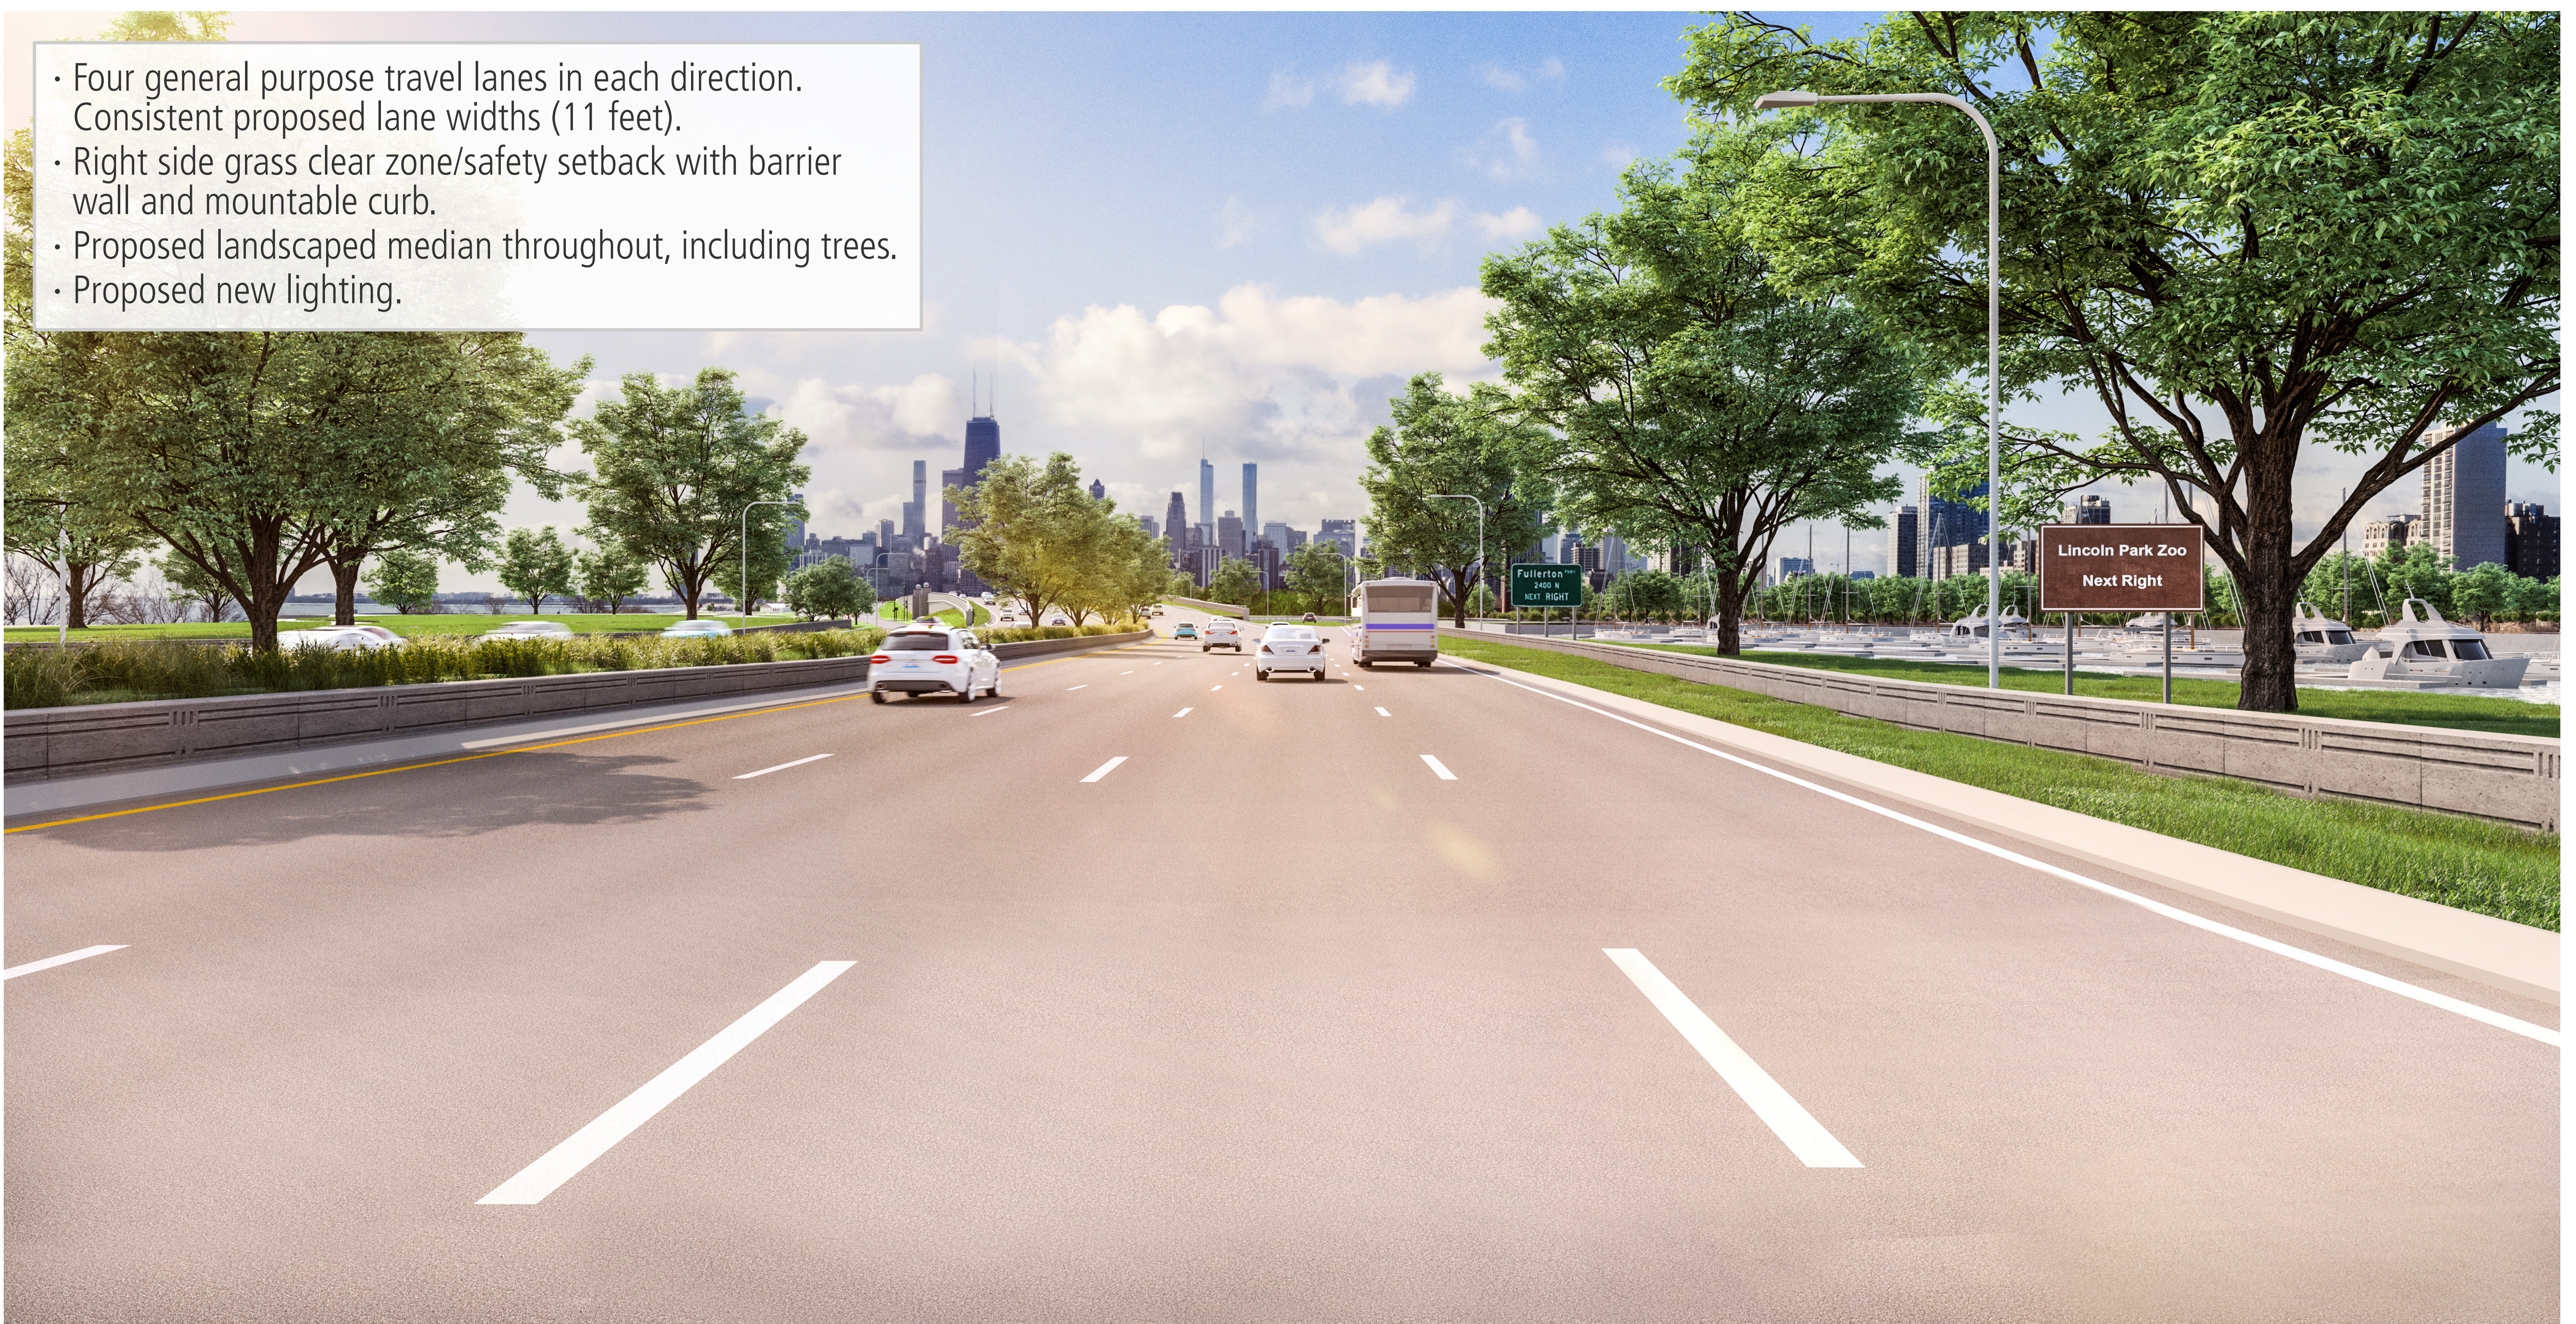
The Essential

- Four general purpose travel lanes in each direction. Consistent proposed lane widths (11 feet).
- Right side grass clear zone/safety setback with barrier wall and mountable curb.
- Proposed landscaped median throughout, including trees.
- Proposed new lighting.
