**TYPICAL ROADWAY NORTH OF FULLERTON PARKWAY**

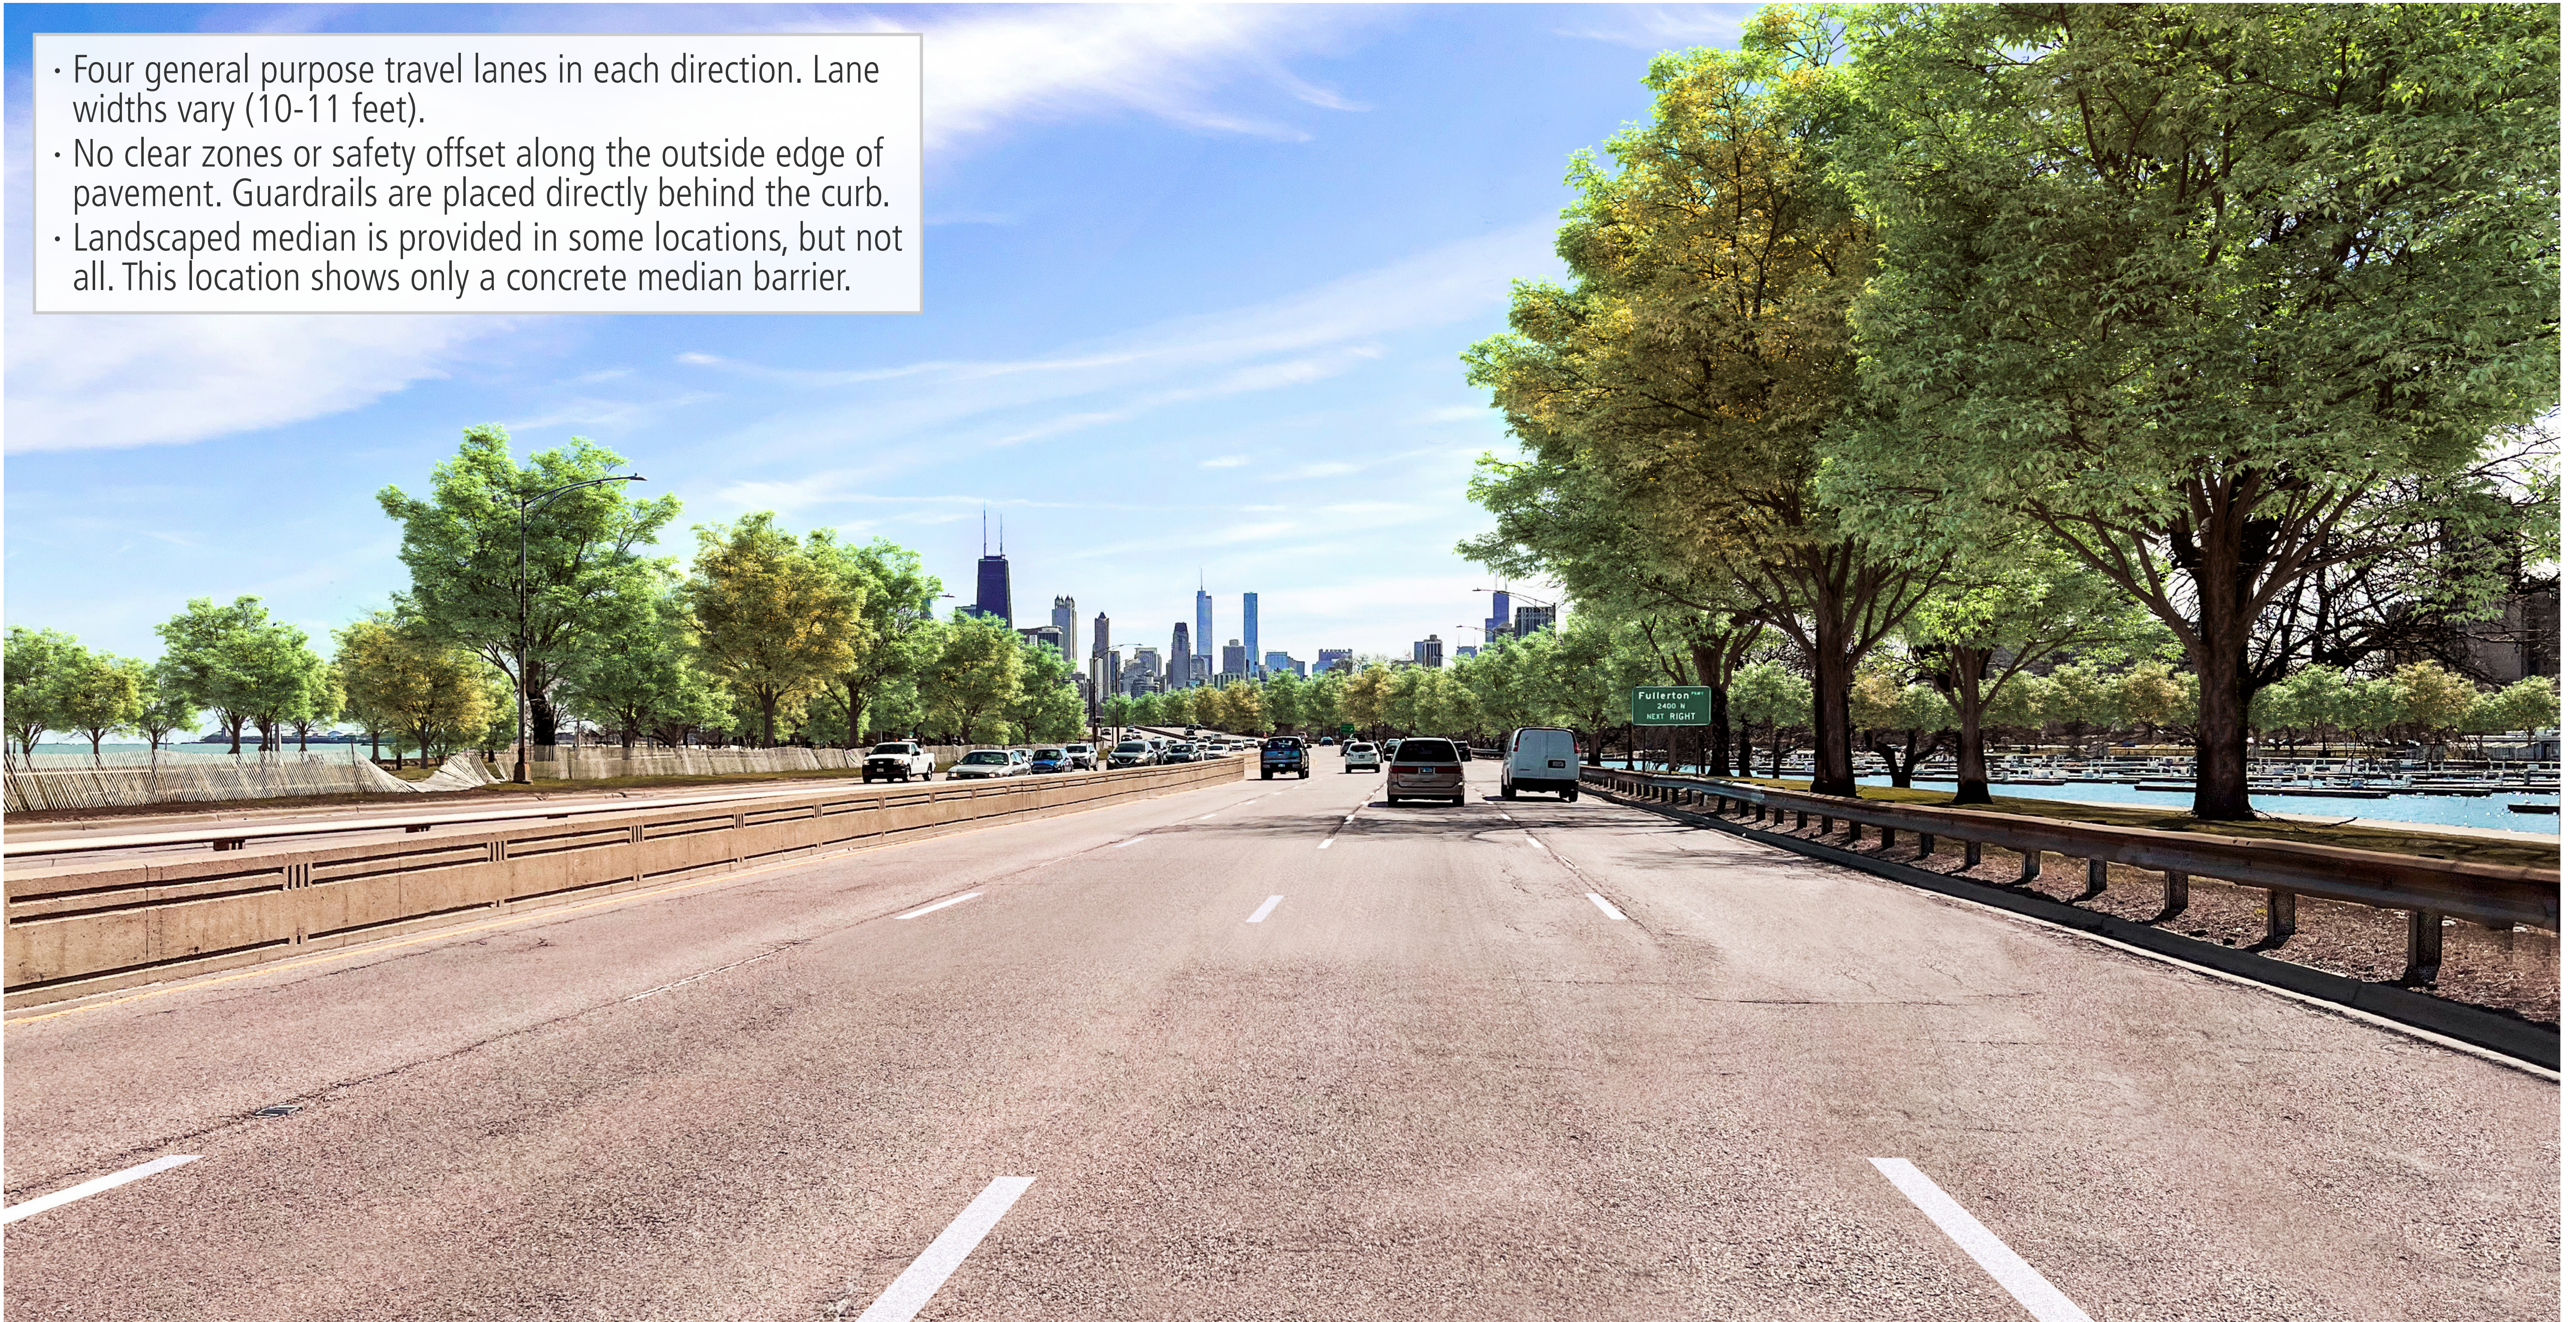
**Existing Conditions**

- Four general purpose travel lanes in each direction. Lane widths vary (10-11 feet).
- No clear zones or safety offset along the outside edge of pavement. Guardrails are placed directly behind the curb.
- Landscaped median is provided in some locations, but not all. This location shows only a concrete median barrier.

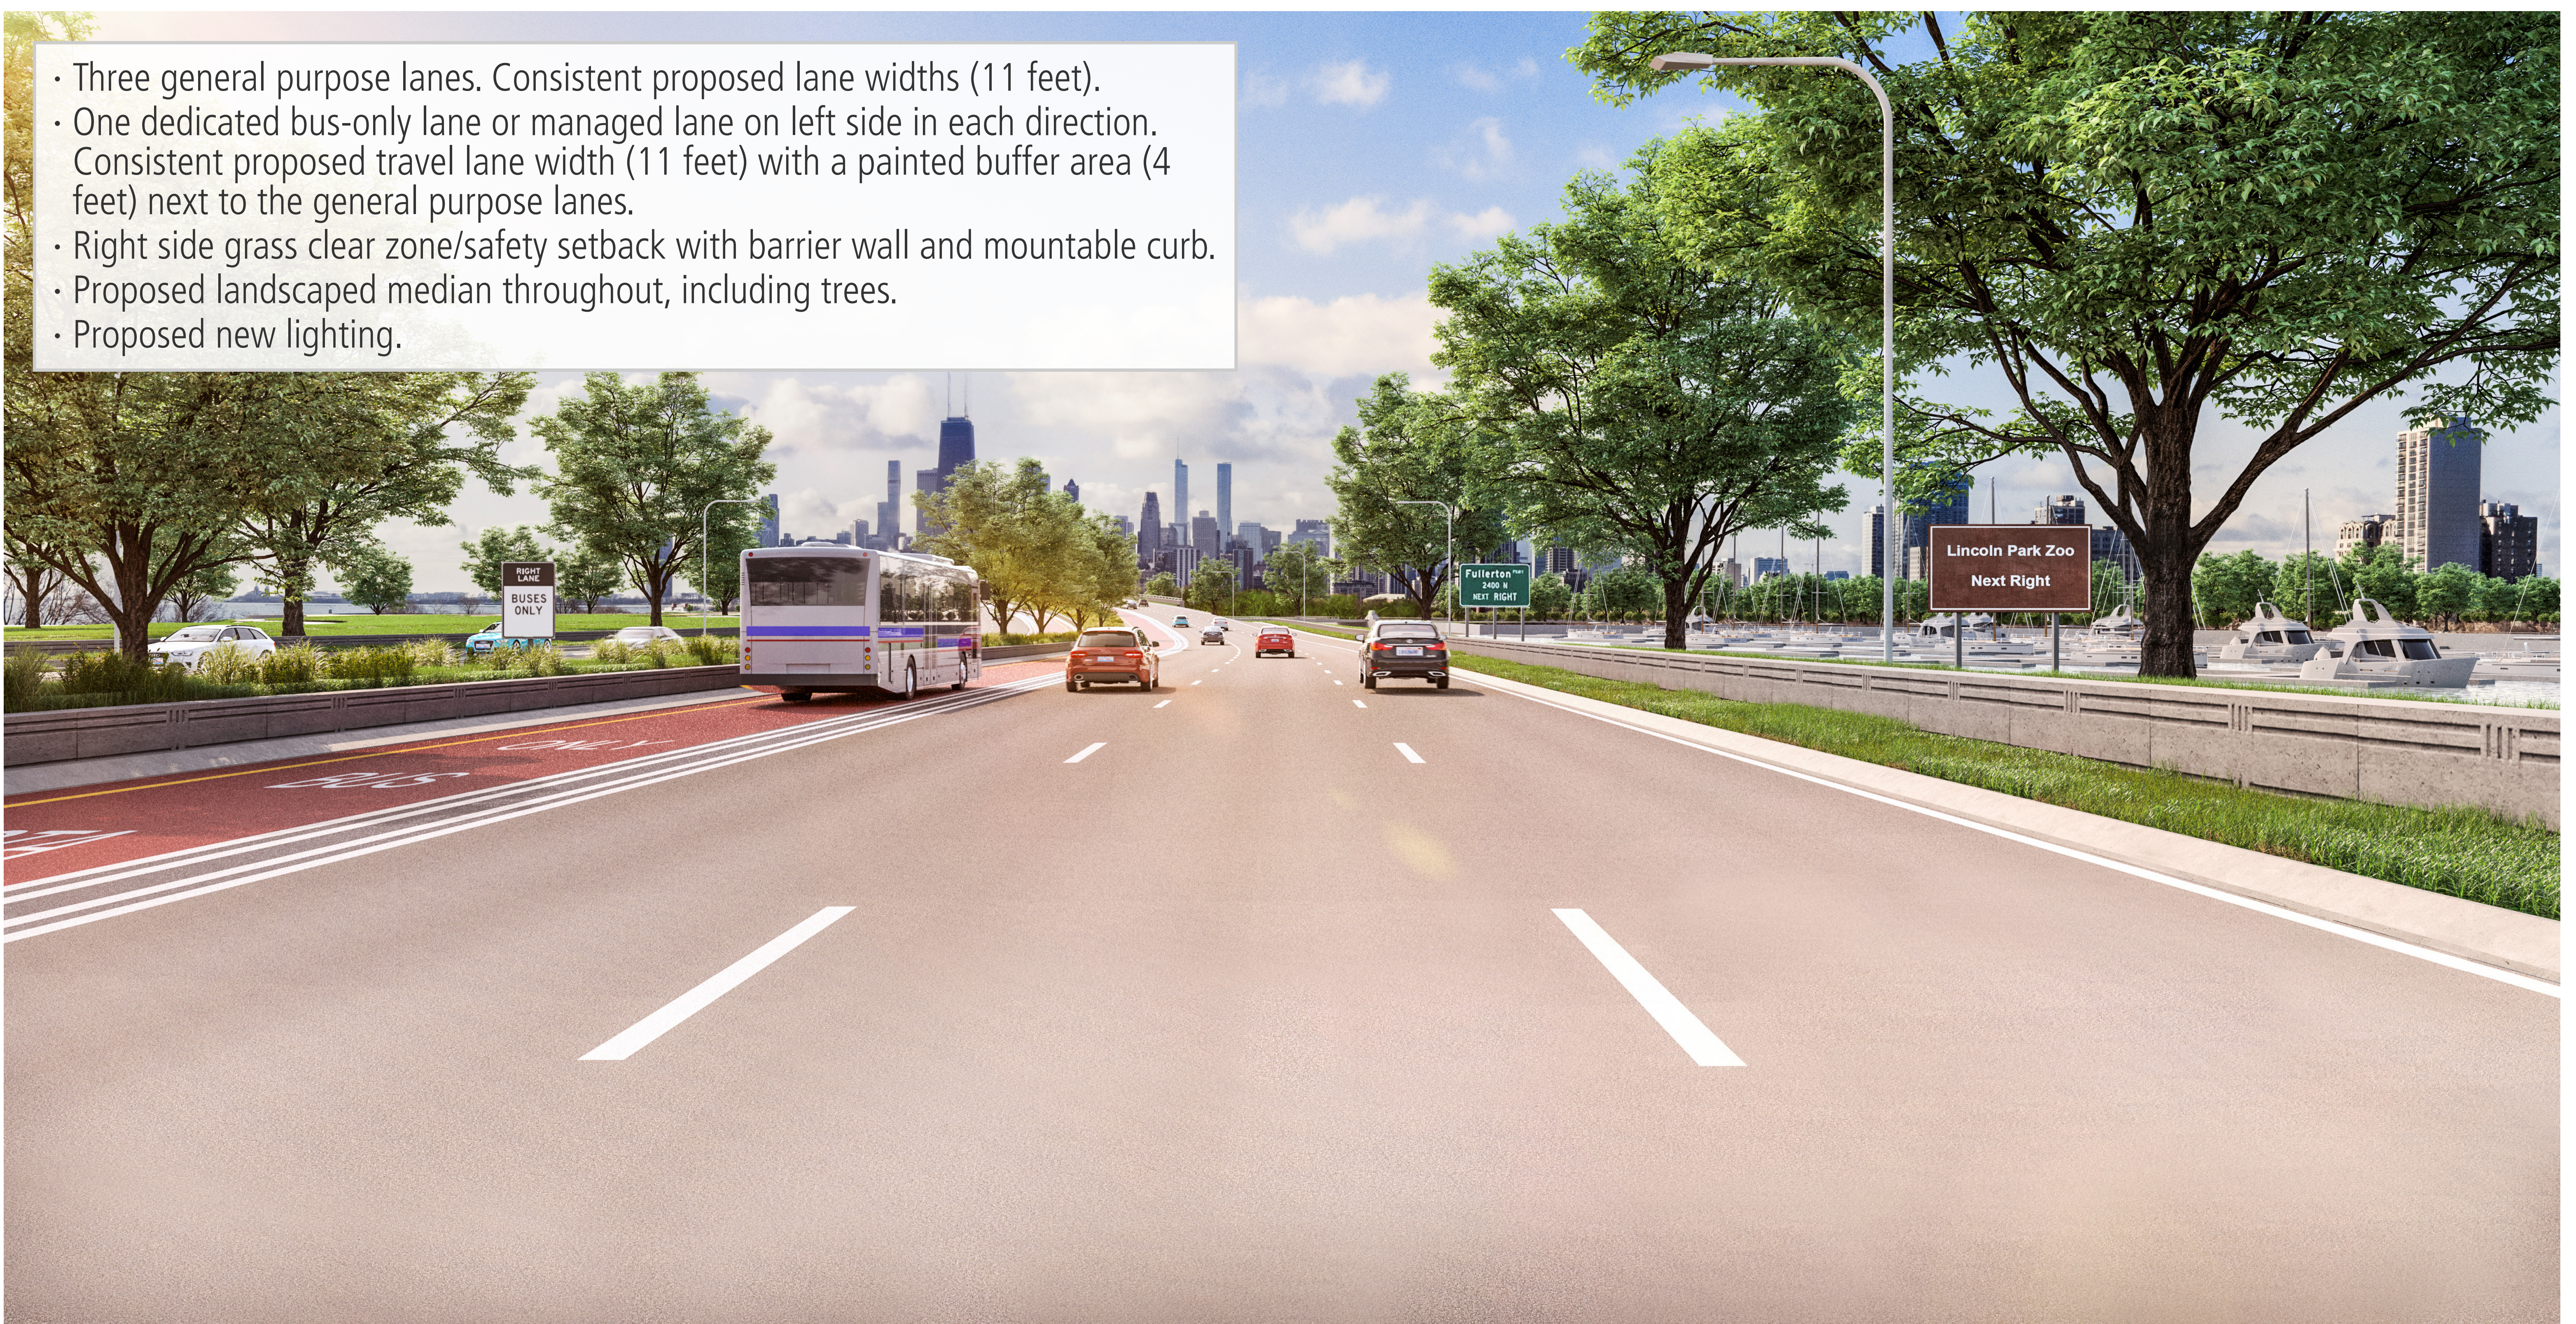
**The Exchange / Flex**

- Three general purpose lanes. Consistent proposed lane widths (11 feet).
- One dedicated bus-only lane or managed lane on left side in each direction. Consistent proposed travel lane width (11 feet) with a painted buffer area (4 feet) next to the general purpose lanes.
- Right side grass clear zone/safety setback with barrier wall and mountable curb.
- Proposed landscaped median throughout, including trees.
- Proposed new lighting.
