OAK STREET CURVE

Existing Conditions

Potential Future Condition

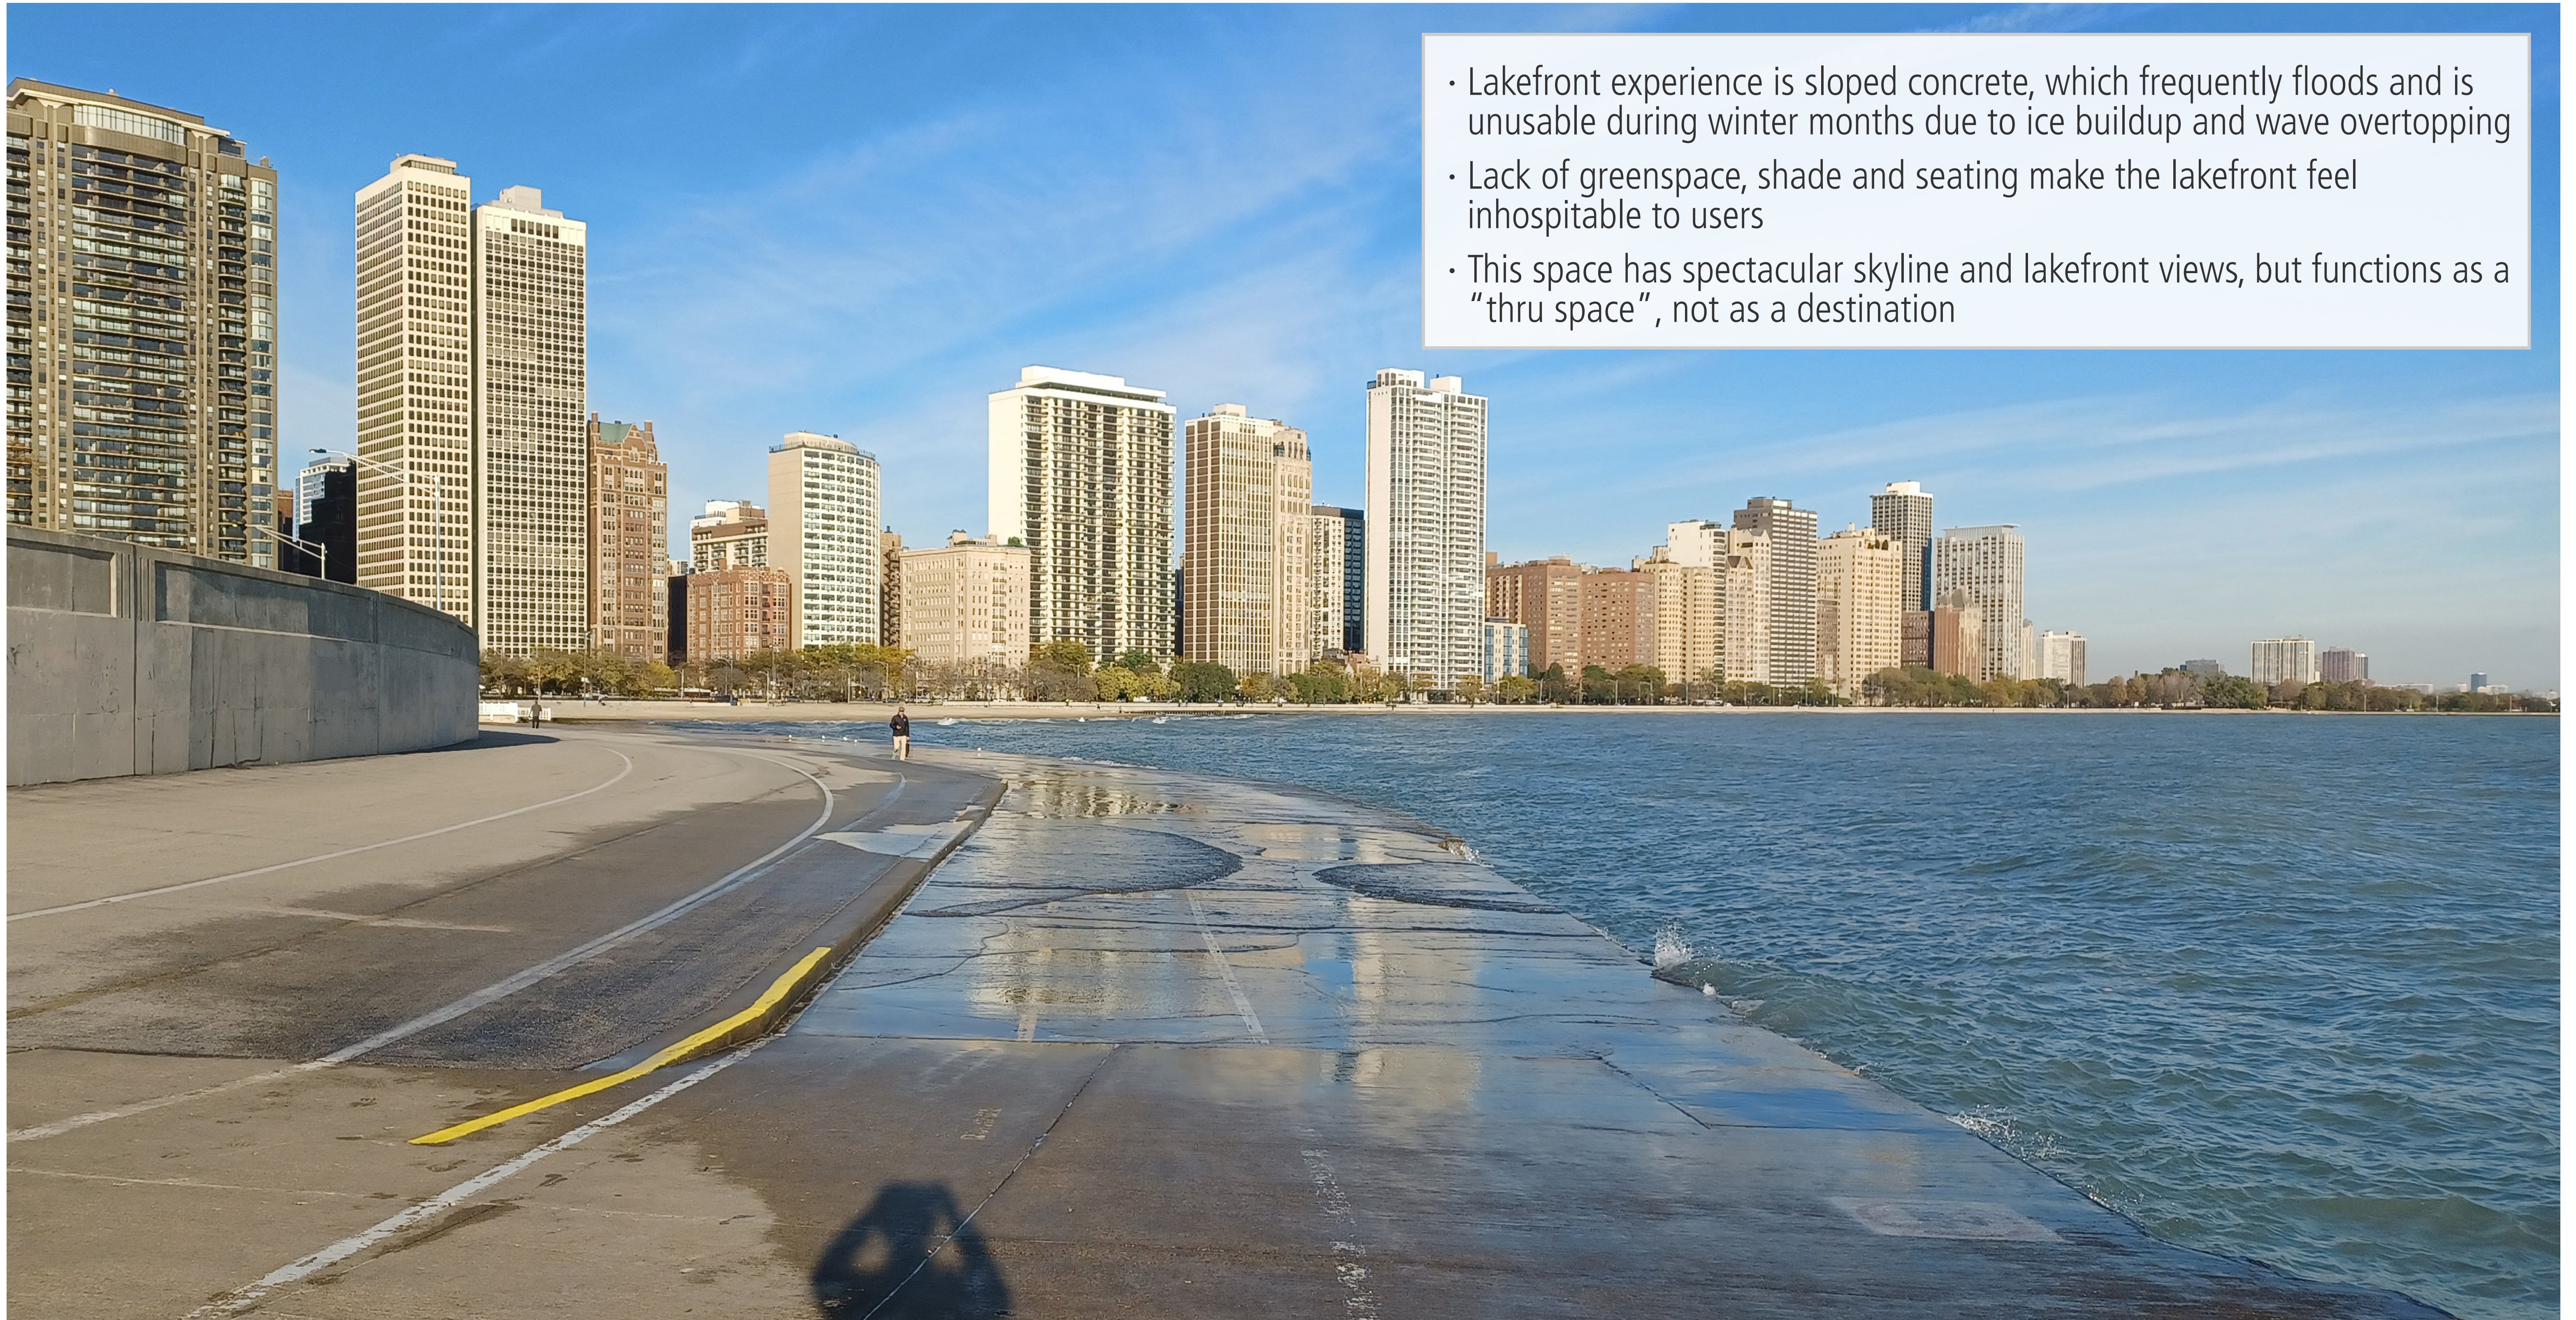
- Lakefront experience is sloped concrete, which frequently floods and is unusable during winter months due to ice buildup and wave overtopping
- Lack of greenspace, shade and seating make the lakefront feel inhospitable to users
- This space has spectacular skyline and lakefront views, but functions as a "thru space", not as a destination

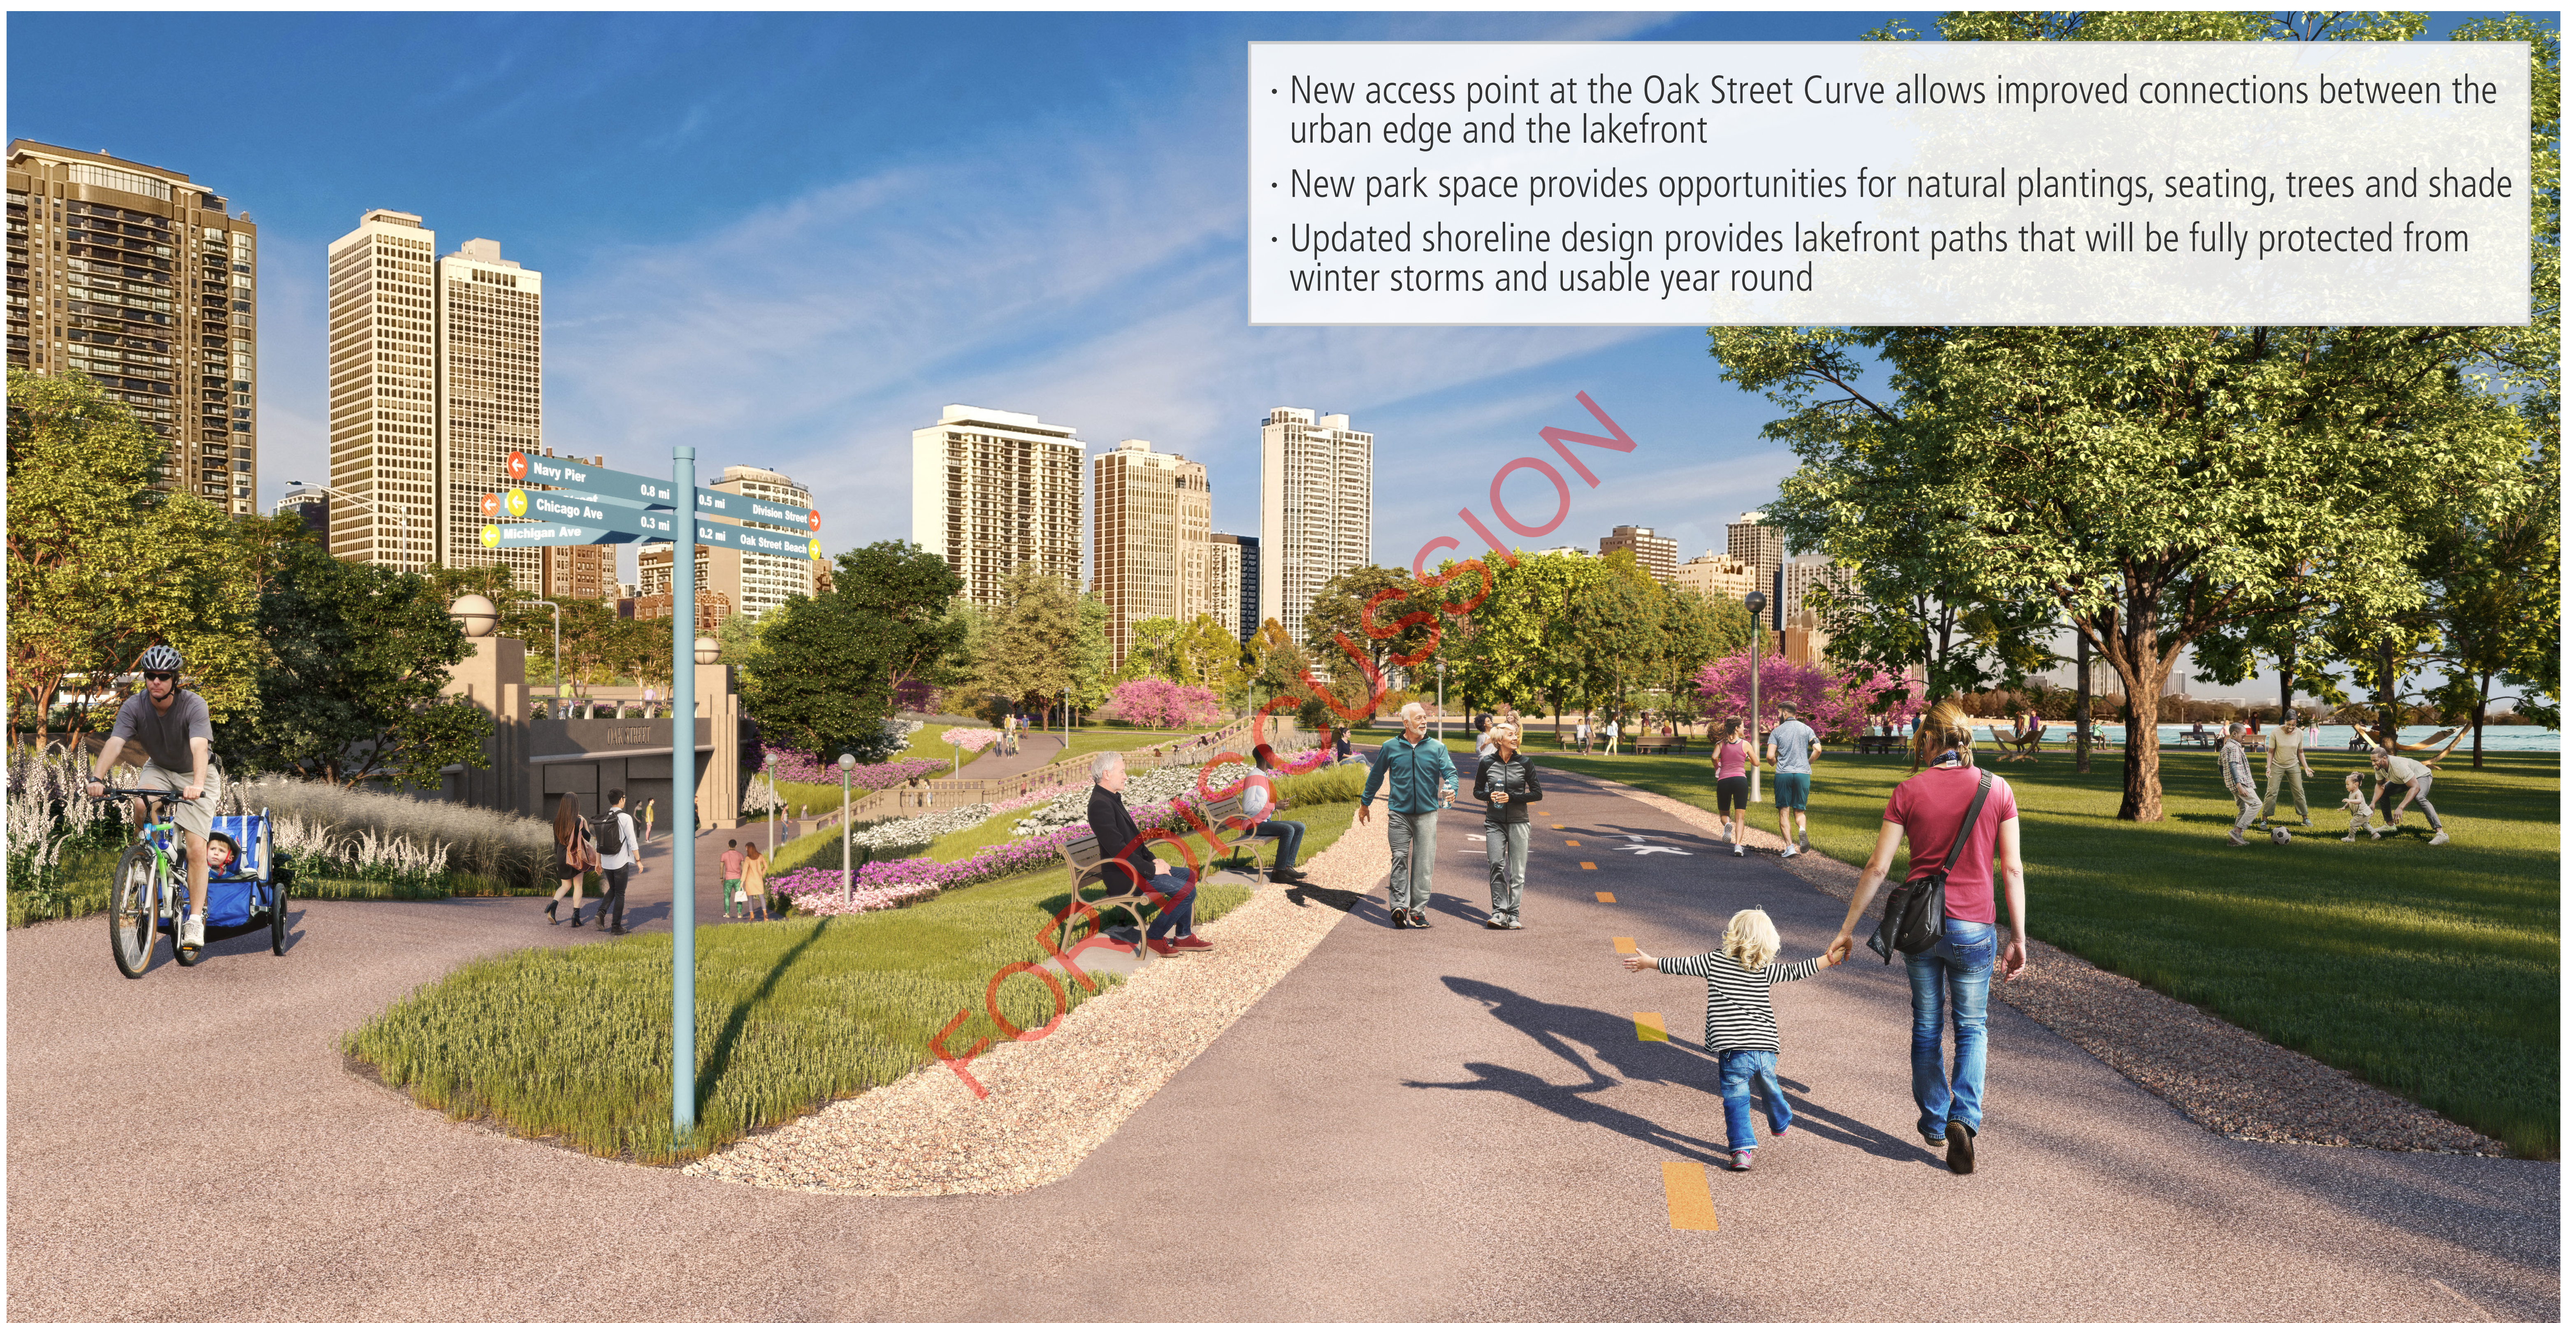
- New access point at the Oak Street Curve allows improved connections between the urban edge and the lakefront
- New park space provides opportunities for natural plantings, seating, trees and shade
- Updated shoreline design provides lakefront paths that will be fully protected from winter storms and usable year round
